# ROAD SAFETY AUDIT

Route 20

Town of Oxford/Town of Charlton

April 2016

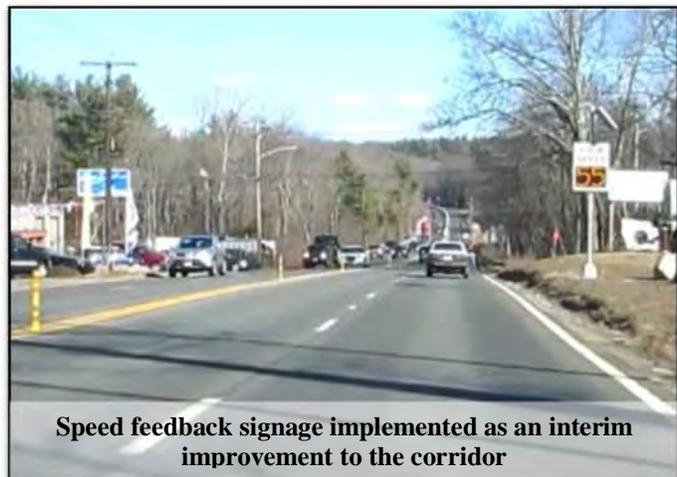
The interim improvements that were installed include radar speed feedback signage. The signs are positioned in the eastbound and westbound direction in advance of the horizontal curve adjacent to Oak Drive. It was noted during the RSA meeting that while the speed feedback signage is a positive improvement to help reduce vehicle speeds, the posted speed limit signage is missing at these locations for drivers to compare actual travel speeds to the posted speed limit.

- Consider including the speed limit signage at the two existing speed feedback signs implemented as part of the interim improvements.
- Consider providing advanced signage designating specific areas where U-turns should be made, particularly for heavy vehicles.
- Consider providing truck turn-out areas at designated U-turn locations (such as Richardson Corner Road) to allow larger vehicles to make the movements.
- Update GPS information to be consistent with current roadway conditions.

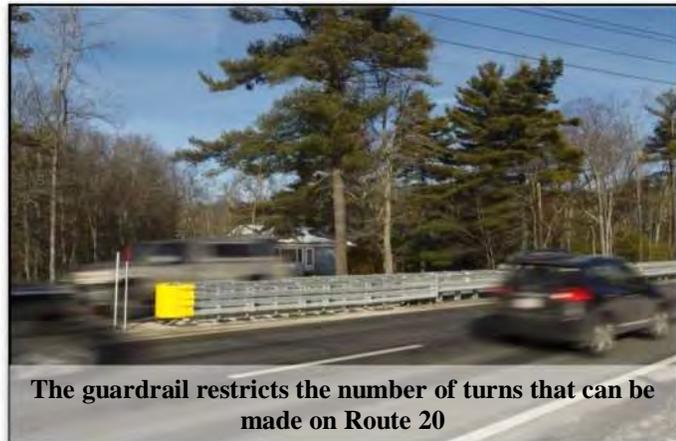
It should be noted that the currently proposed redesign of Route 20 includes installation of a permanent median barrier within the corridor, with left-turns and U-turns to be accommodated at specific locations. Audit team members noted that during the February 22<sup>nd</sup> public information meeting, it was discussed that any location to the west of

Richardson Corner Road would not be feasible as a U-turn location, as it would be difficult to educate and enforce people to bypass Richardson Corner Road. It was discussed by audit team members that this U-turn location would not be a feasible solution until the reconstruction project is constructed. However, the construction of a U-turn truck turnout as an interim improvement was widely supported by RSA participants.

- Evaluate locations for right-of-way acquisition to provide appropriate U-turn locations. Specifically, the property adjacent to Pioneer Drive (a former Chinese restaurant) was identified by audit participants.
- Consider providing breaks in Route 20 barriers to facilitate U-turns for emergency response vehicles as a long-term measure.
- Consider modifications to private driveways to allow for efficient egress of larger vehicles with the addition of the new guardrail.
- Consider installation of additional delineator posts with shorter spacing between posts at both ends of the new guardrail to discourage U-turn movements using private driveways.

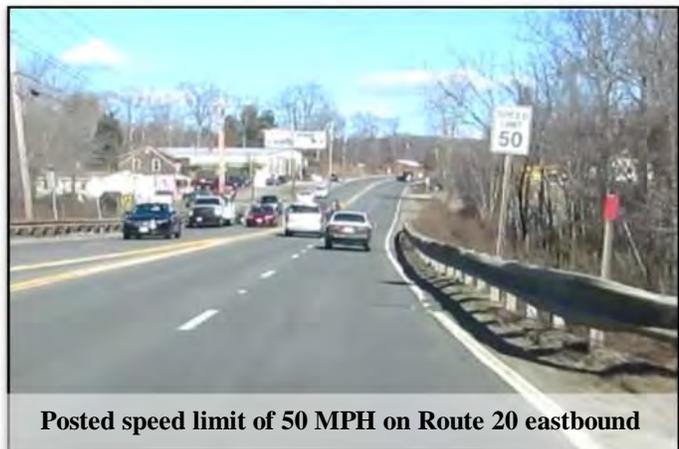
With regard to crash data, single vehicle crashes account for 25% of the total corridor crashes, which may indicate that there is a geometric problem with the roadway, or that vehicles are traveling too fast to safely traverse the roadway without losing control of their vehicle. Inclement weather may also be a factor as four of these single vehicle crashes occurred in wet/snow conditions. As shown in the crash diagrams, seven crashes occurred at the curve near Oak Street over the crash period reviewed where vehicles lost control of their vehicles and collided into a stationary object or with another vehicle; the fatal crash in October 2015 also occurred within this curve.

- Evaluate design improvements for the central and western segments of Route 20 that will reduce vehicle speeds and allow for a speed limit reduction.
- Consider providing larger sized speed limit signage to help alert drivers of the posted speed limit.
- Consider adding additional regulatory signs with speed feedback signs throughout the corridor to alert motorists of their current travel speeds, and include the posted speed limit to supplement the feedback signage.
- Evaluate locations that can be utilized as designated pull-off areas to aid in police enforcement of the posted speed limit.
- Investigate funding sources to provide additional police enforcement.
- Consider providing advisory speed warning signage at locations where the roadway geometry requires vehicles to slow down.

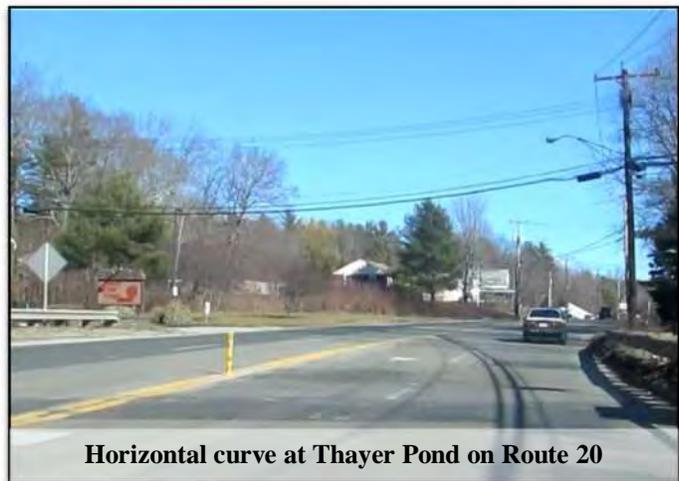
Audit team members discussed several locations where sight distance was an issue within the corridor. The first location is at the entrance to Thayer Pond, a residential development located on Route 20 approximately 750 feet east of Route 56. There is a slight horizontal curve at this location that obstructs sight lines from vehicles exiting the development. Additionally, queues from the westbound approach of the intersection of

**Horizontal curve at Thayer Pond on Route 20**

Route 20 at Route 56 often extend beyond this driveway during the weekday afternoon peak hour. It is difficult for vehicles to see the upcoming queue on Route 20 traveling westbound, which may be a contributing factor in the number of rear-end collisions at this location.

- Evaluate relocating the Thayer Pond driveway to a location on Route 20 with better sight lines to improve driveway sight distance.
- Evaluate improvements, including traffic signal retiming, at the intersection of Route 56 and Route 20 to reduce queuing in the westbound direction on Route 20.

- Consider installing dynamic queue (or “Red Signal Ahead”) signage in the westbound direction approaching Route 56 to alert motorists of queuing conflicts.

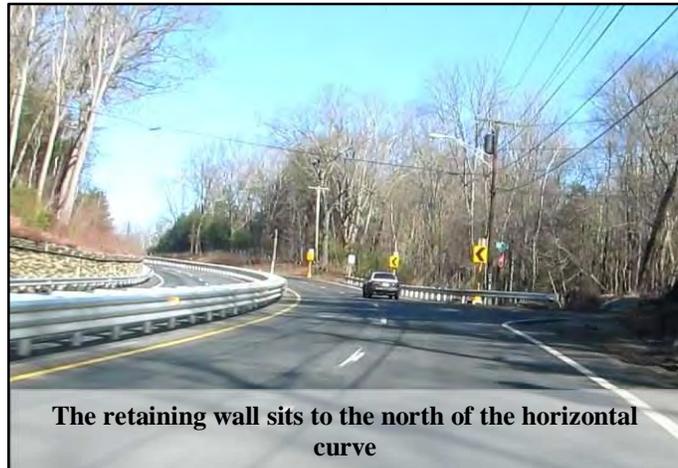
Perhaps the largest discussion of roadway geometry is at the horizontal curve adjacent to Oak Drive. The interim improvements of the guardrail, speed feedback signage, and dynamic warning chevrons are short-term mitigation to help reduce crashes at this location. To the north of the roadway, the land is steeply graded and a retaining wall is located around the curve as well. Audit participants noted that

horizontal alignment improvements could be made if the retaining wall were removed and the land were regraded, but it would be costly mitigation.

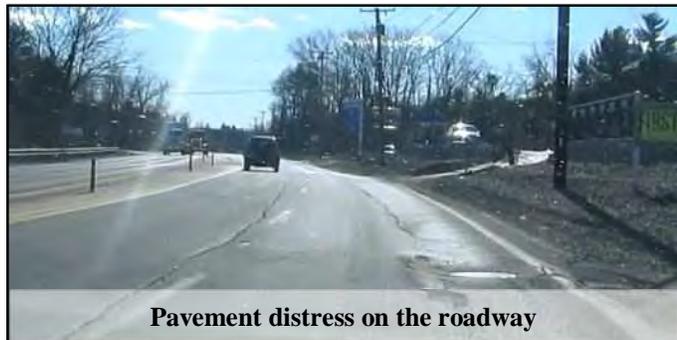
It was also noted during the audit that there are several roadside obstructions that may be a contributing factor to the number of single vehicle collisions such as utility poles and unprotected sign posts. Additionally, since Route 20 is an east/west facing roadway, solar glare was noted by audit participants to be an issue, particularly during the weekday afternoon for westbound traffic.

- Consider resurfacing the remaining sections of Route 20 that were not resurfaced with the implementation of the interim improvements to improve traction on the roadway surface.
- Consider providing warning signage in advance of locations where icing is expected to warn motorists of the upcoming hazard.
- Evaluate drainage structure improvements to reduce the amount of water left on the roadway.
- Consider tree trimming in areas where icing is expected to increase the amount of sunlight on the roadway to melt the ice.
- Provide a police presence to monitor areas where solar glare is most significant.
- Replace the missing speed limit sign to post the speed limit at 40 miles per hour in the westbound direction on Route 20 approaching Route 56.
