-- PRINDLE LAKE DAM --

PHASE I

INSPECTION / EVALUATION REPORT

Date of Inspection: JUNE 6, 2008

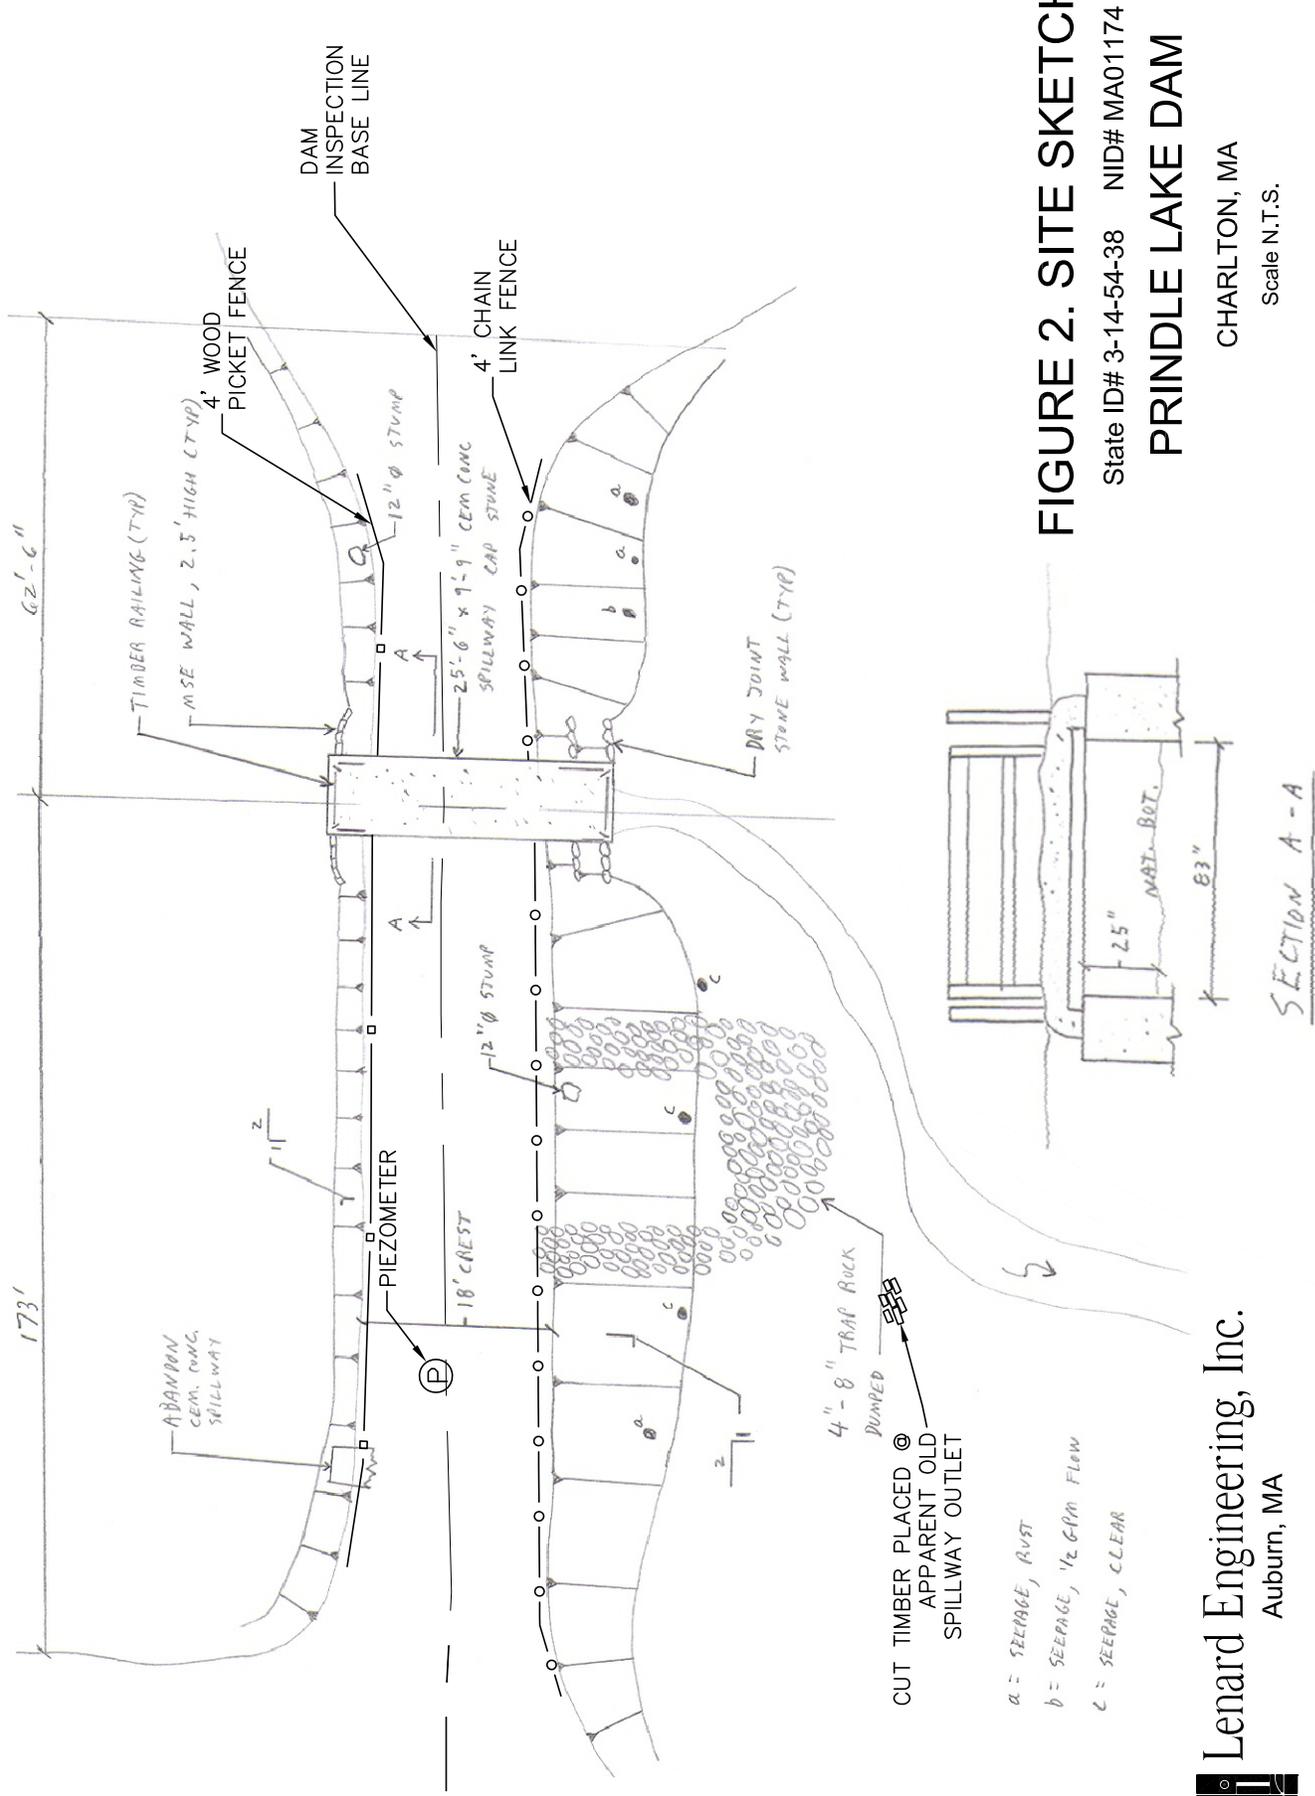
CUT TIMBER PLACED @ APPARENT OLD SPILLWAY OUTLET

- a = SEEPAGE, RUST
- b = SEEPAGE, 1/2 GPM FLOW
- c = SEEPAGE, CLEAR

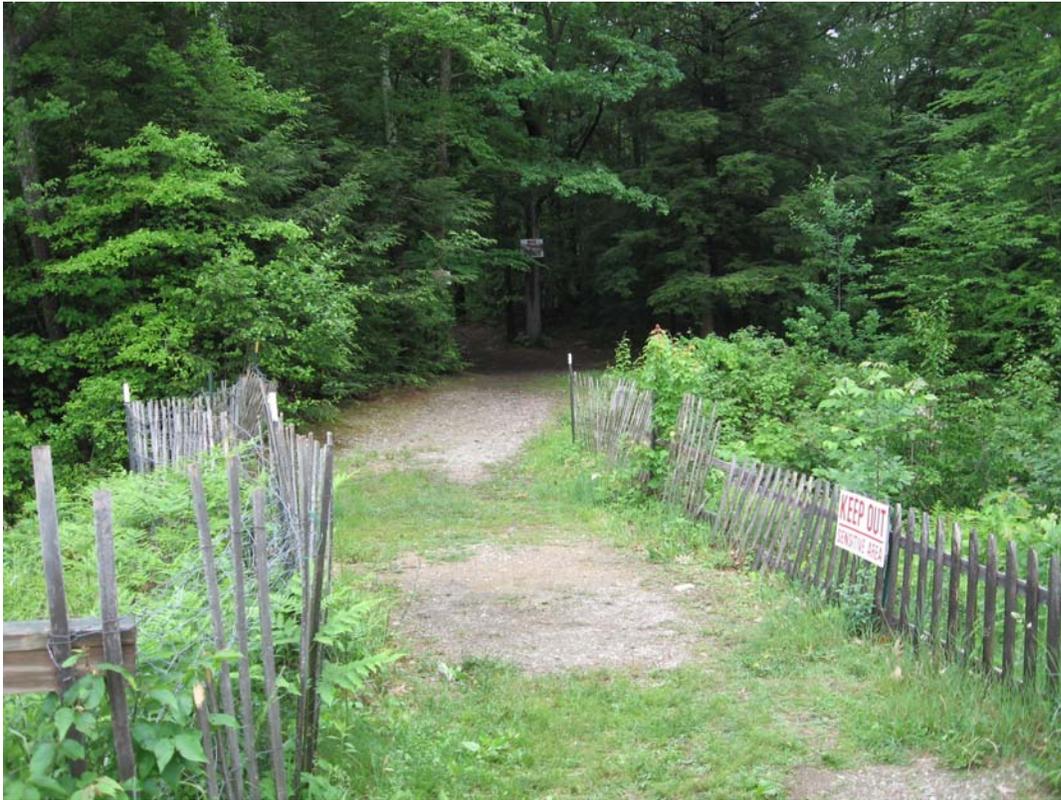
Photo 001. Standing on spillway looking at left abutment

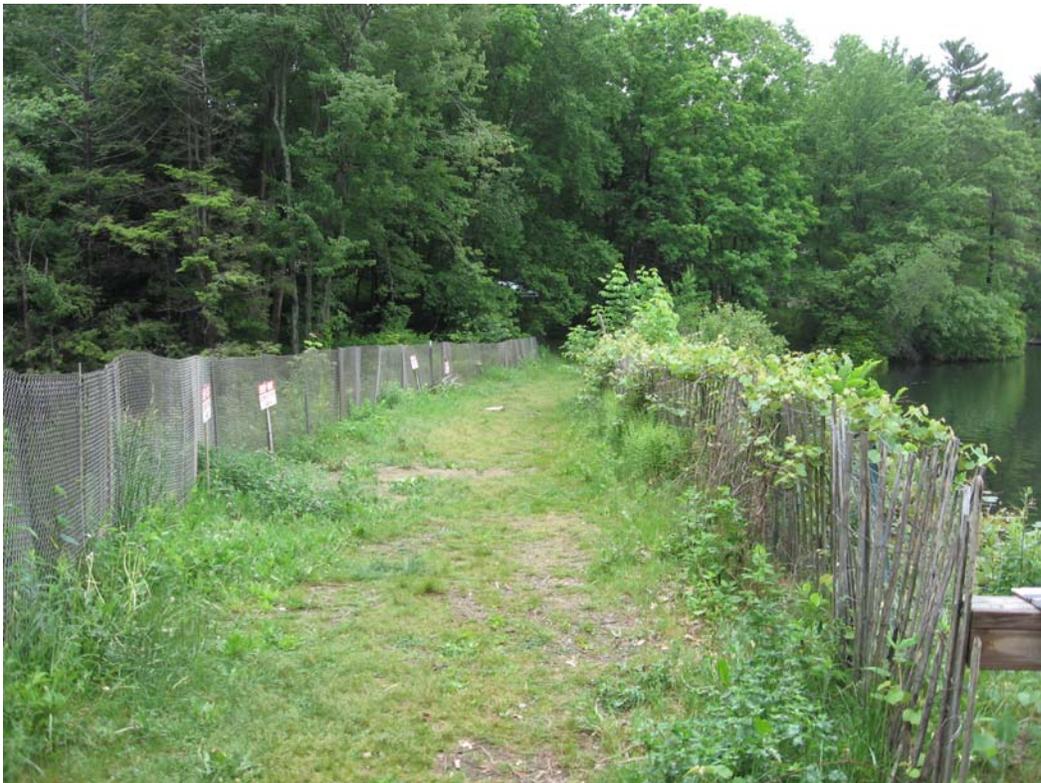
The upstream face is covered with broad leaf vegetation, which made observation difficult (Photo 002). The face is possibly covered with earth and riprap. Some brushy vegetation was observed on the right side with a 12" tree stump located on the left side.

Photo 002. Standing on spillway looking right along crest

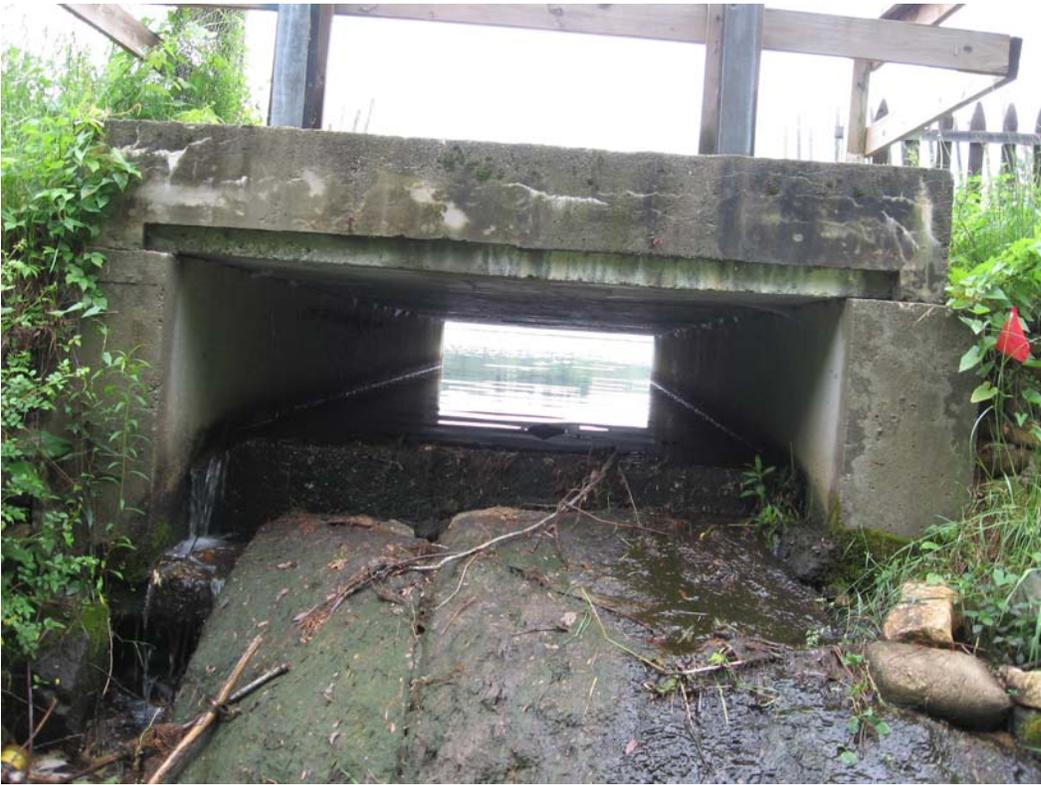
The primary spillway, which is the only defined dam discharge, consists of a cast in place concrete slab supported on 16" wide cast-in-place concrete abutments (Photo 003). The top of the slab is spalled and the condition of the inside of the culvert is satisfactory. No trash rack was observed. However, the culvert appeared to be clear of debris.

Photo 003. Spillway downstream opening

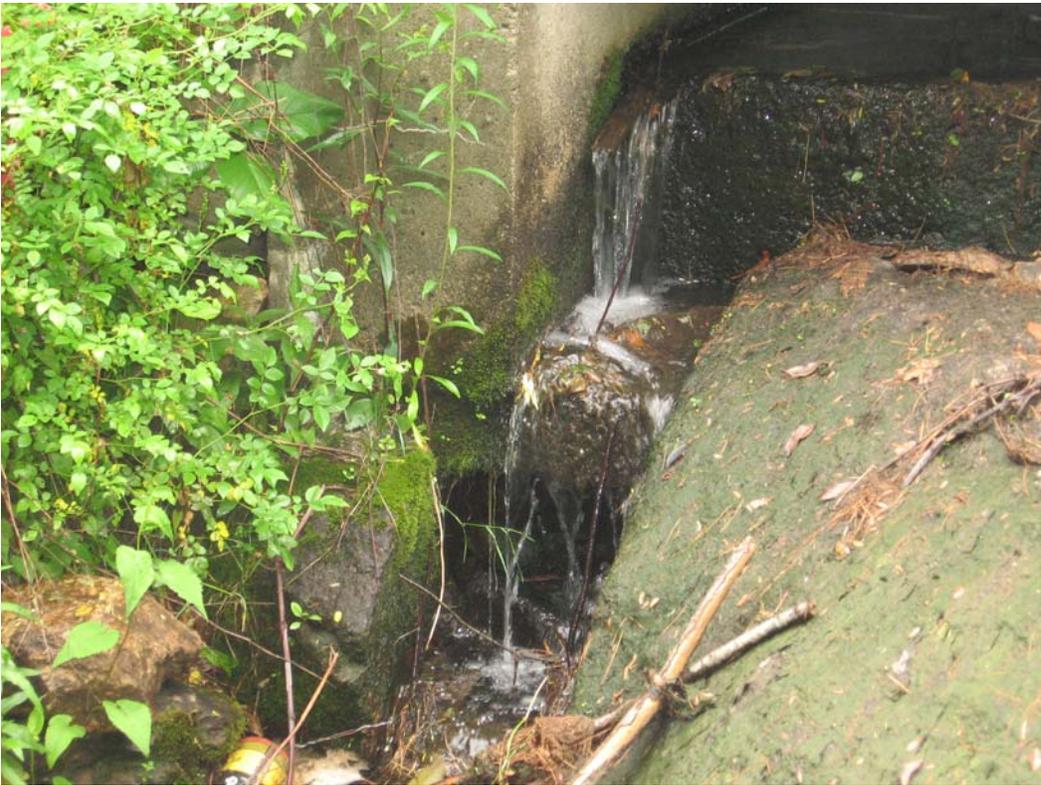
Photo 004. Spillway outlet undermining

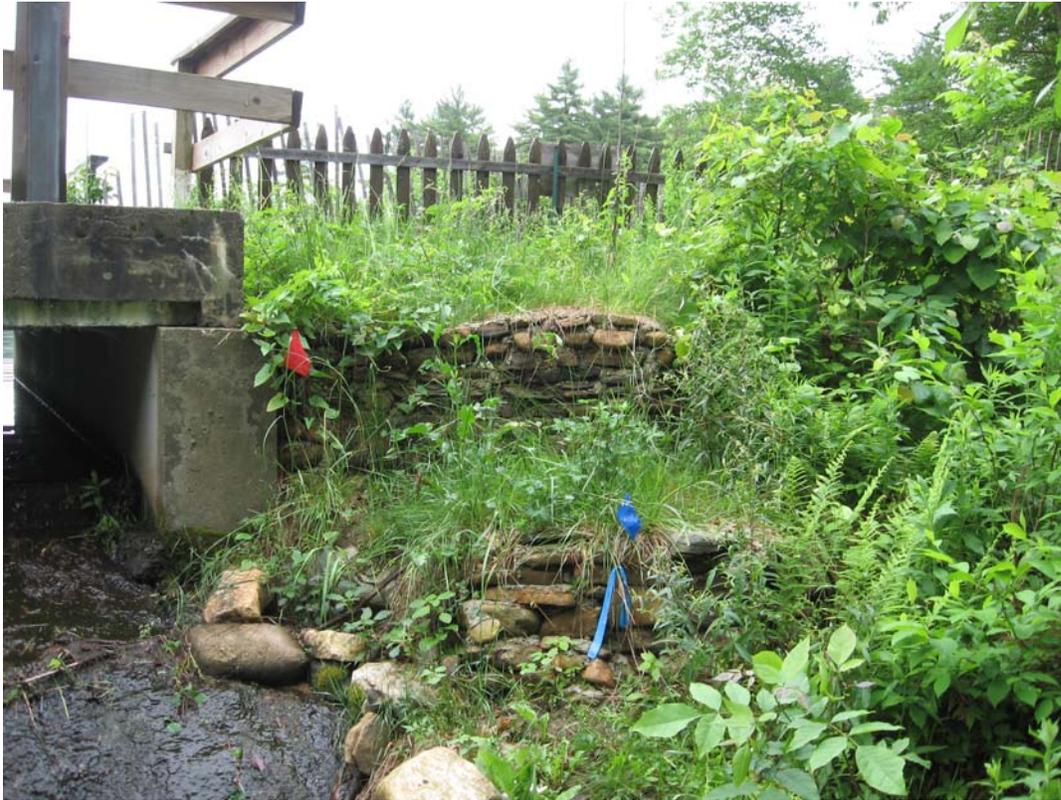
Photo 005. Right of spillway outlet

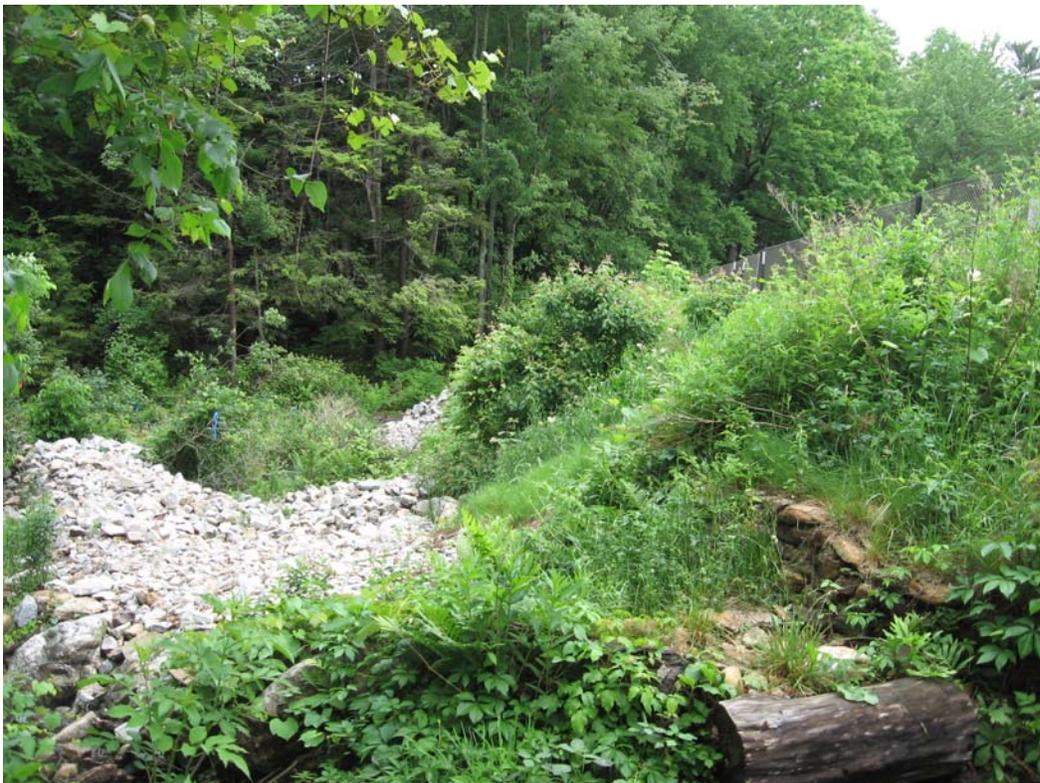
The downstream face is partially covered by broad leaf vegetation (Photos 006 and 010), which made observation difficult. Riprap has been dumped on two areas of the face to the right of the spillway (Photo 010). Some seepage was observed through the riprap on the face. A 12" stump had been left in place to

Photo 006. Downstream face looking right

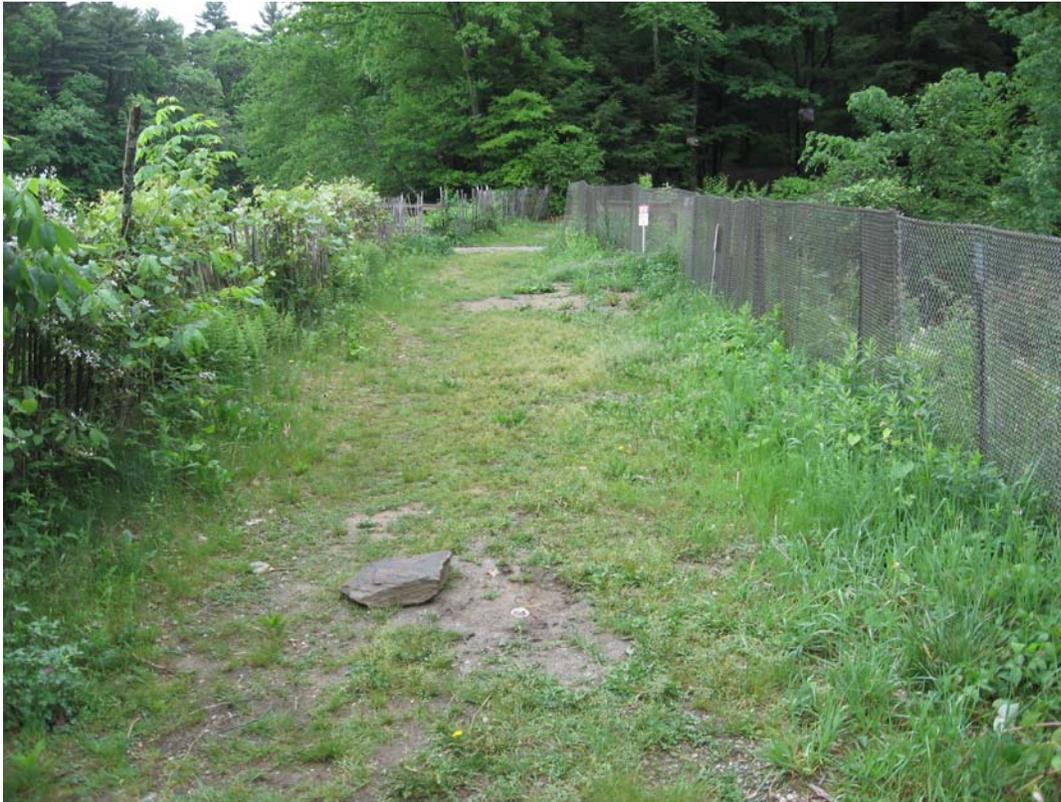
Photo 007. Crest looking right with piezometer location identified by stone

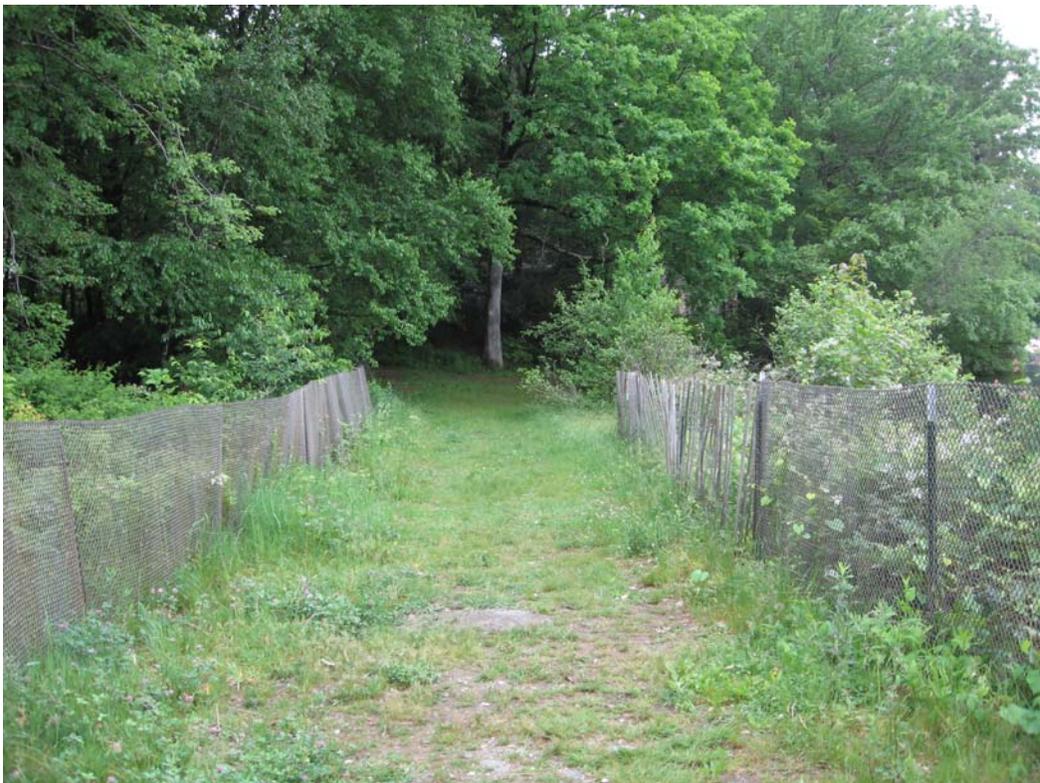
Photo 008. Right abutment

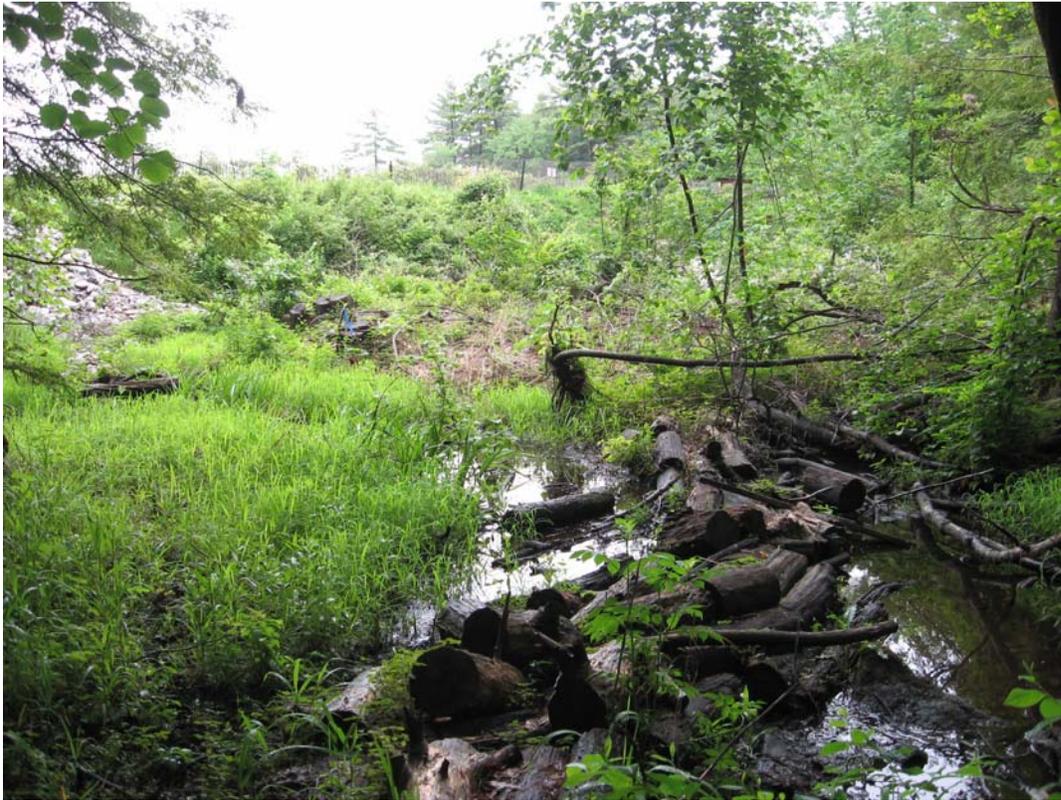
Photo 009. Cut timber placement at apparent old spillway outlet

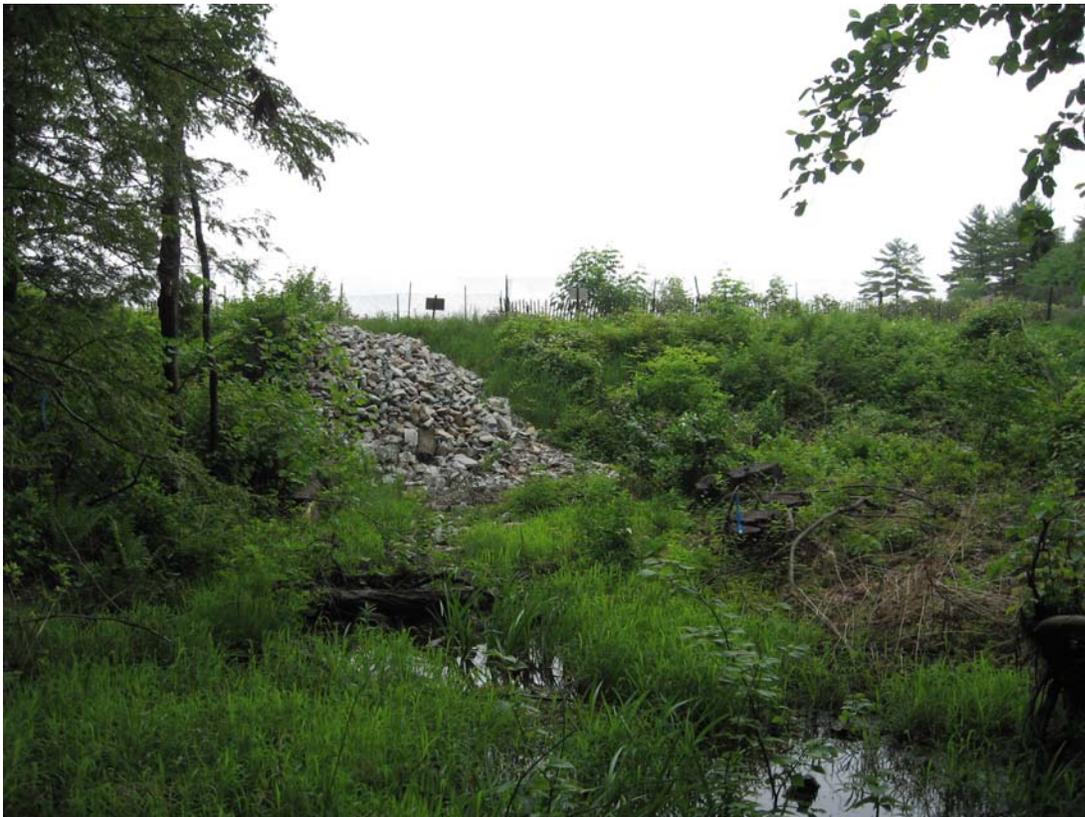
Photo 010. Downstream face with apparent out spillway outlet left of center

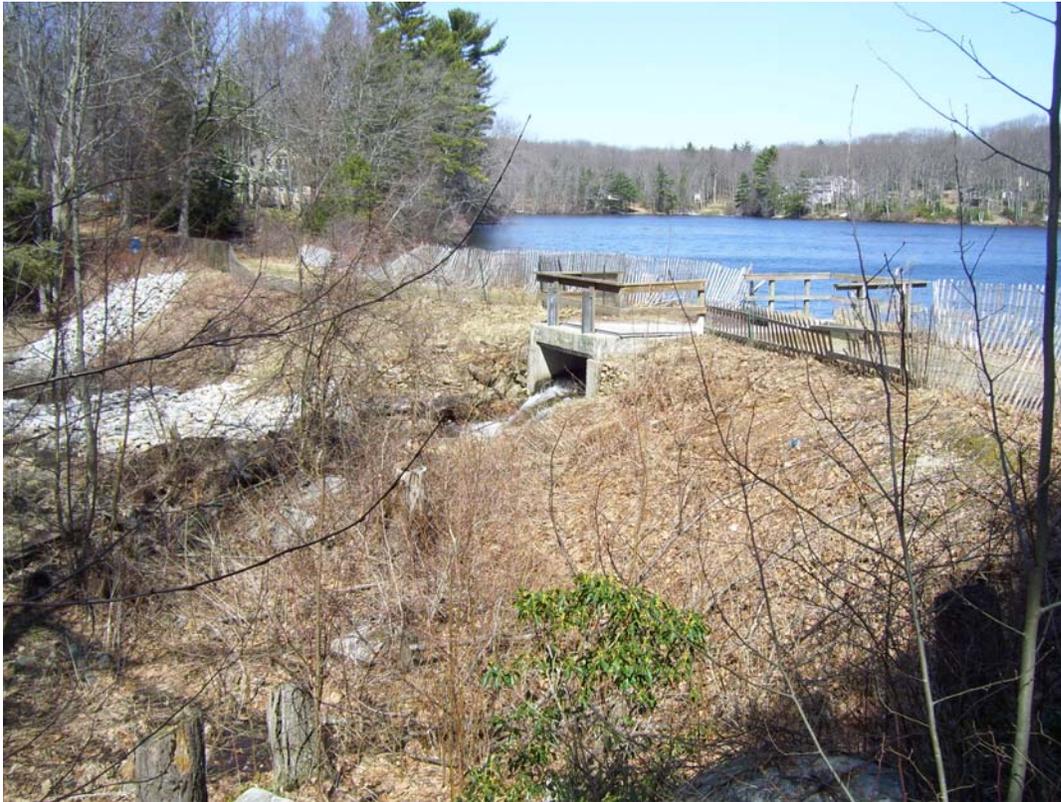
The referenced safety inspection from April 2008 depicts a downstream face condition without broad leaf vegetation (Photo 011-R). This report also depicts an active flow from the apparent abandon spillway (Photo 012-R).

Photo 011-R. Downstream face from April 2008 Inspection

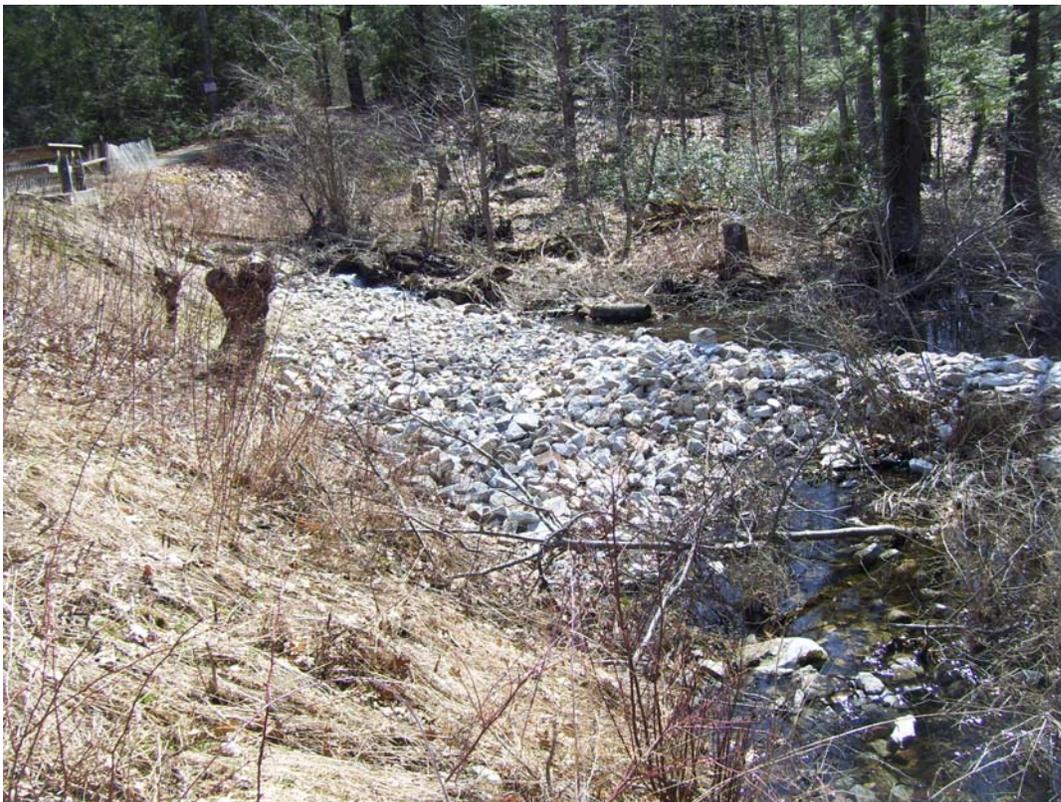
Photo 012-R. Apparent abandon spillway seep from April 2008 Inspection (active spillway in left background)
