CORRECTIVE
ACTION
COMPLETION
CERTIFICATION
REPORT

Flint Road Landfill Closure
90 Flint Road
Charlton, Massachusetts

May 2015

**CDM
Smith**

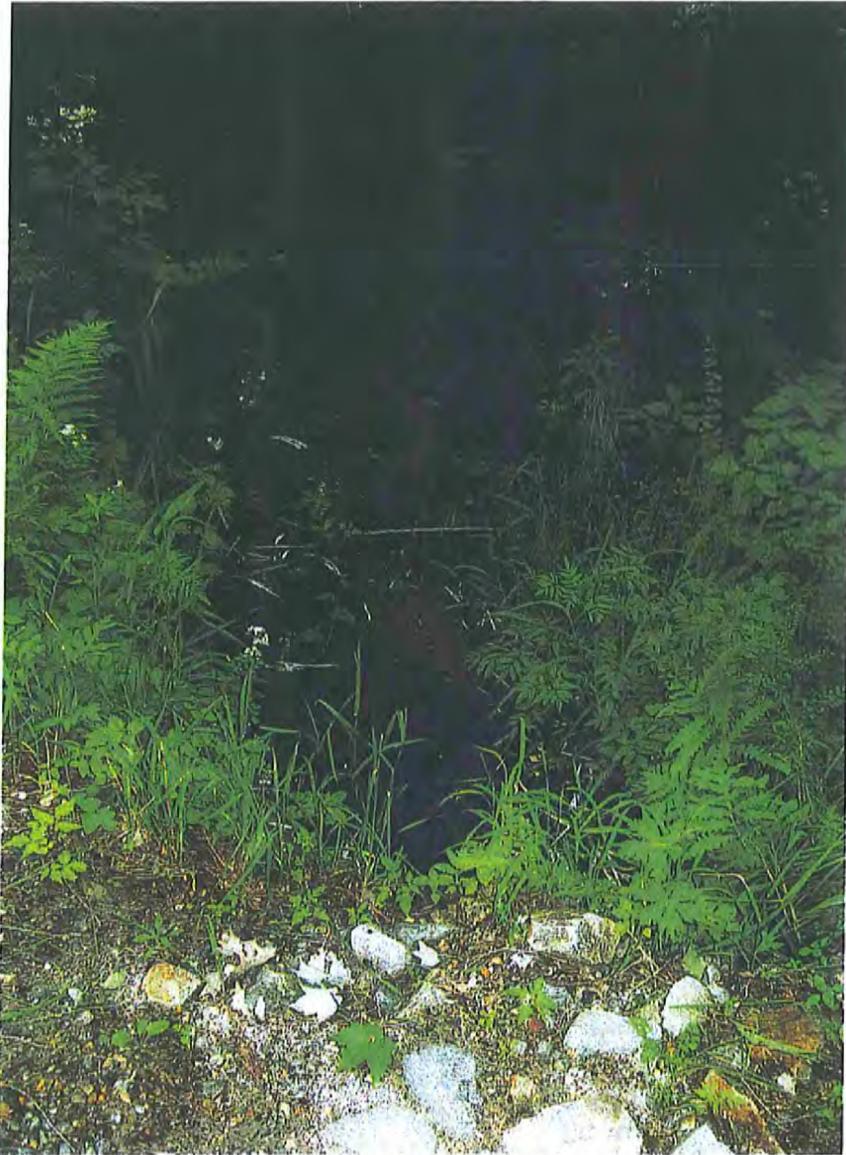
Photo 8: Standing water and siltation on southern side of south site entrance.

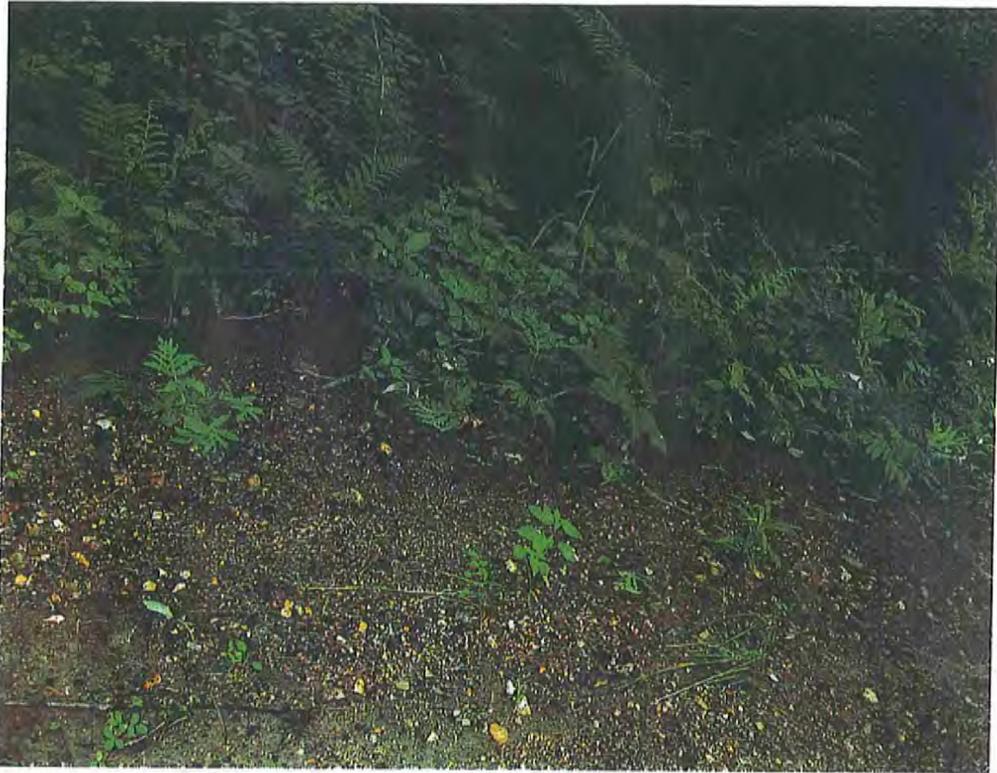
Photo 9: Sediment observed at culvert outlet located on Flint Road, south of southern entrance road to landfill site. Cause of sediment unknown, may be from roadway runoff or landfill.

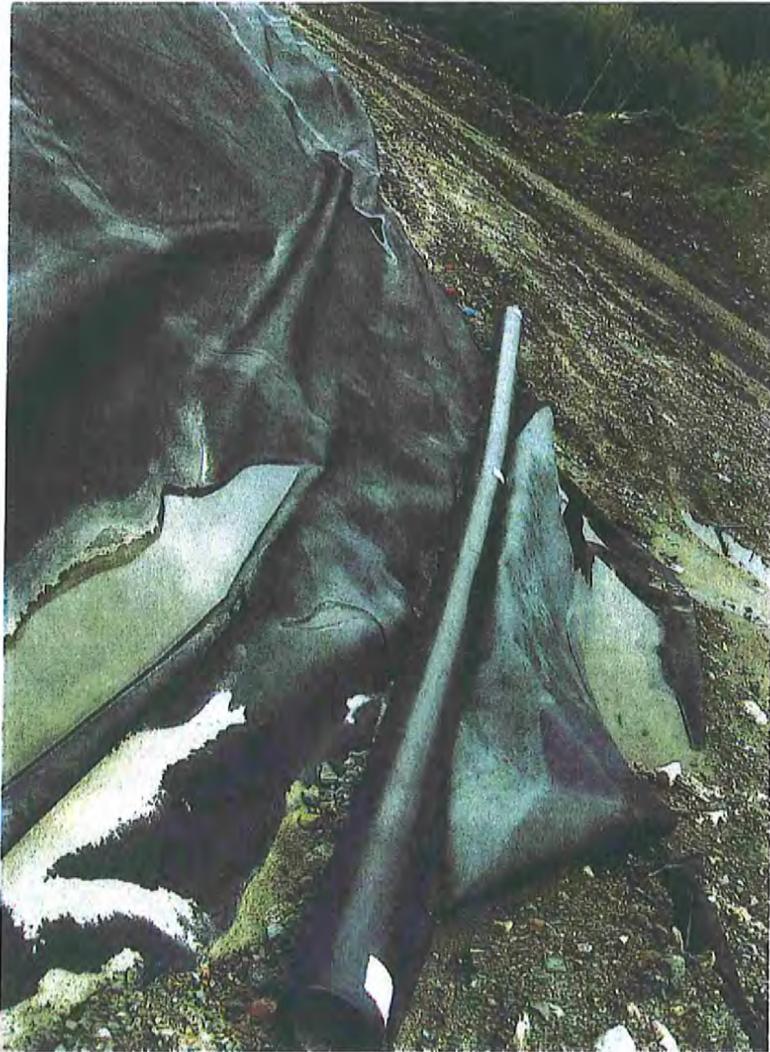
Photo 14: East slope of landfill. Muddy tire tracks observed on liner.

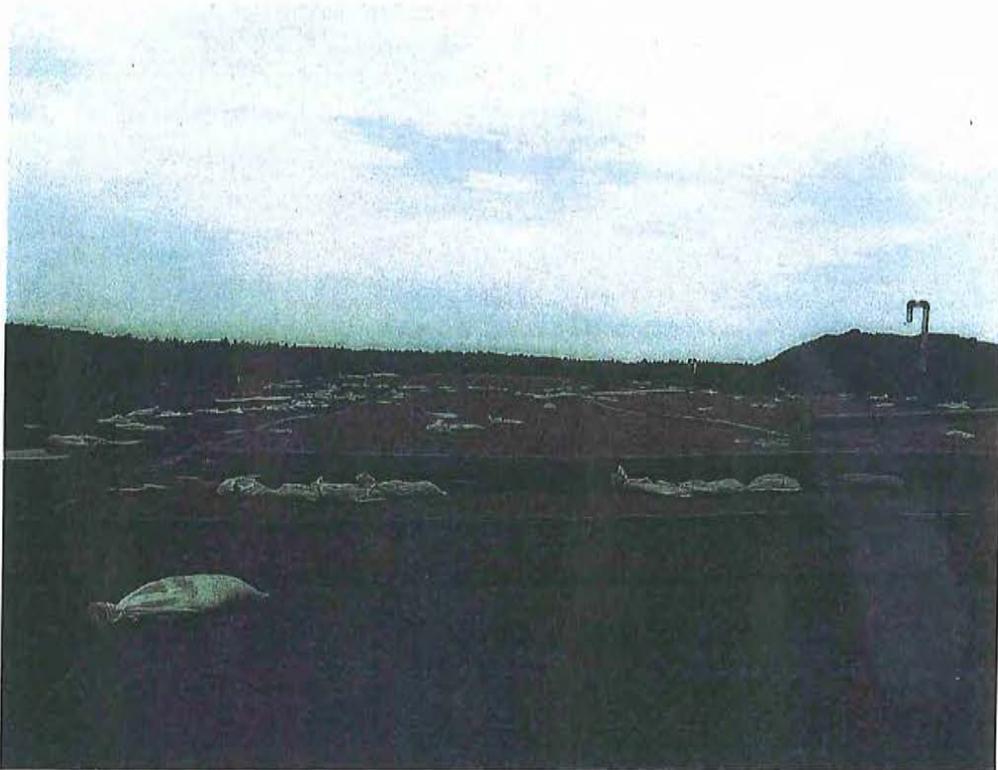
Photo 22: Plateau, facing north-northwest; pile of soil on top of plateau, remnants of liner rolls remain.

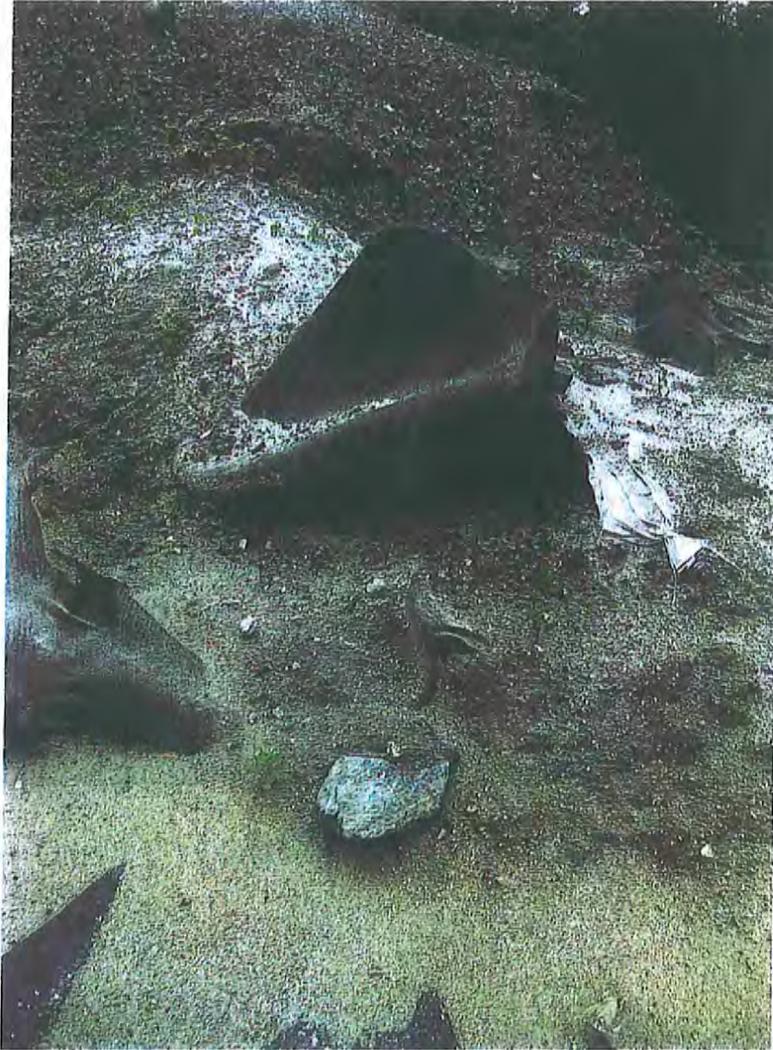
Photo 29: Pile of scrap drainage geocomposite located on plateau area.

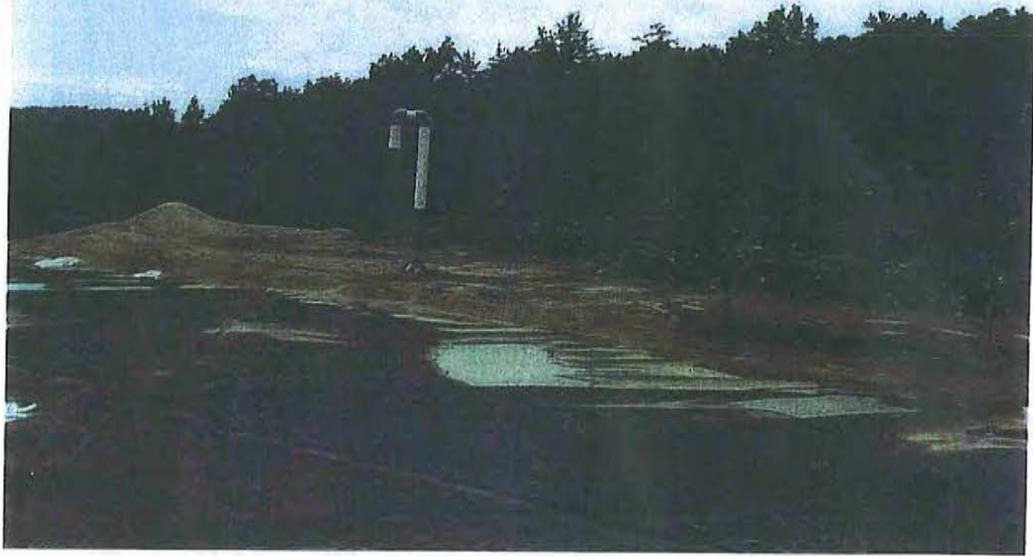
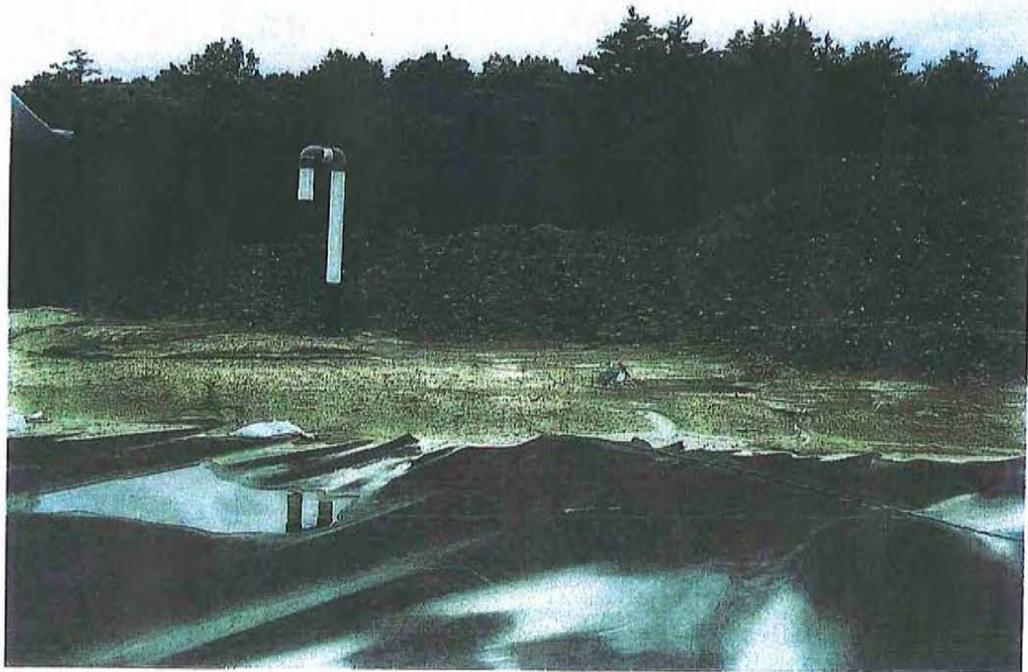
Photo 30: Pile of soils located on northern side of plateau.
Large rock and scrap drainage geocomposite
observed in pile.

Photos 31 & 32: Layer of sand (approximately 6-inches) observed beneath soil pile on plateau.

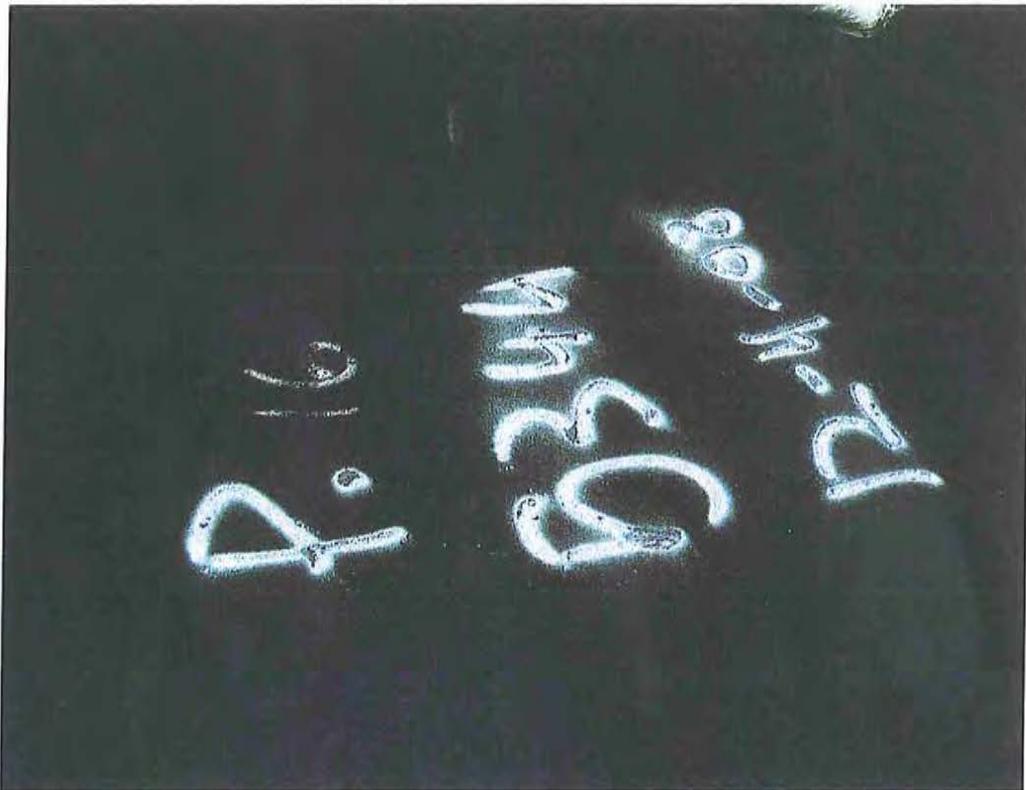
Photo 33: Panel installation QC information on geomembrane.

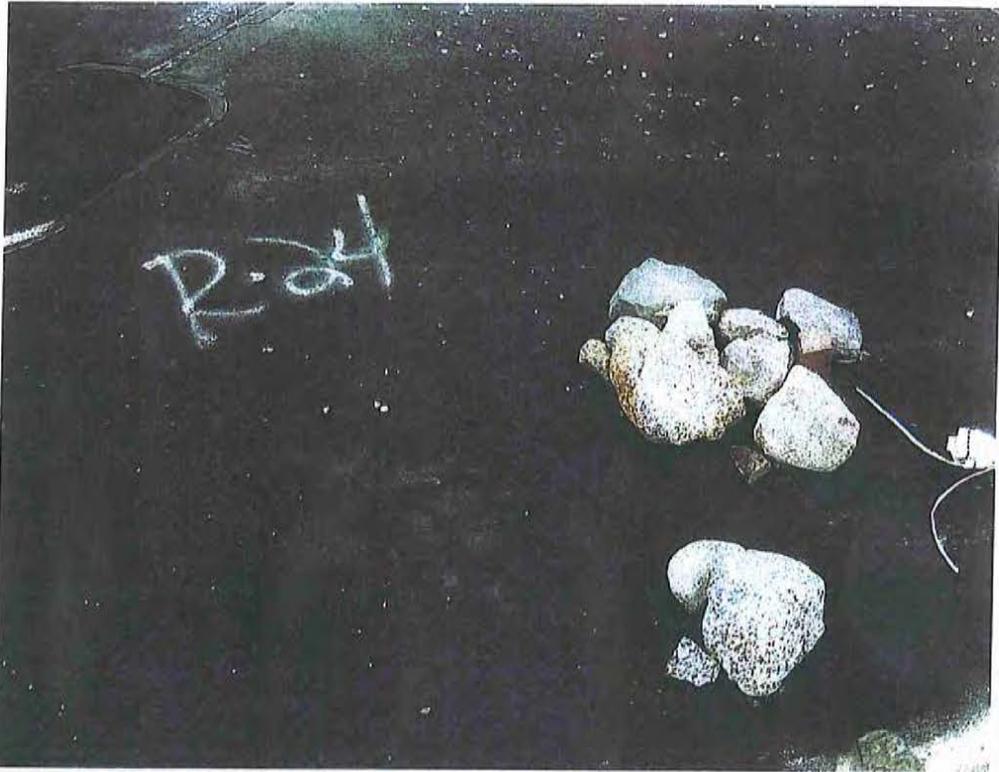
Photo 34: Northern slope.

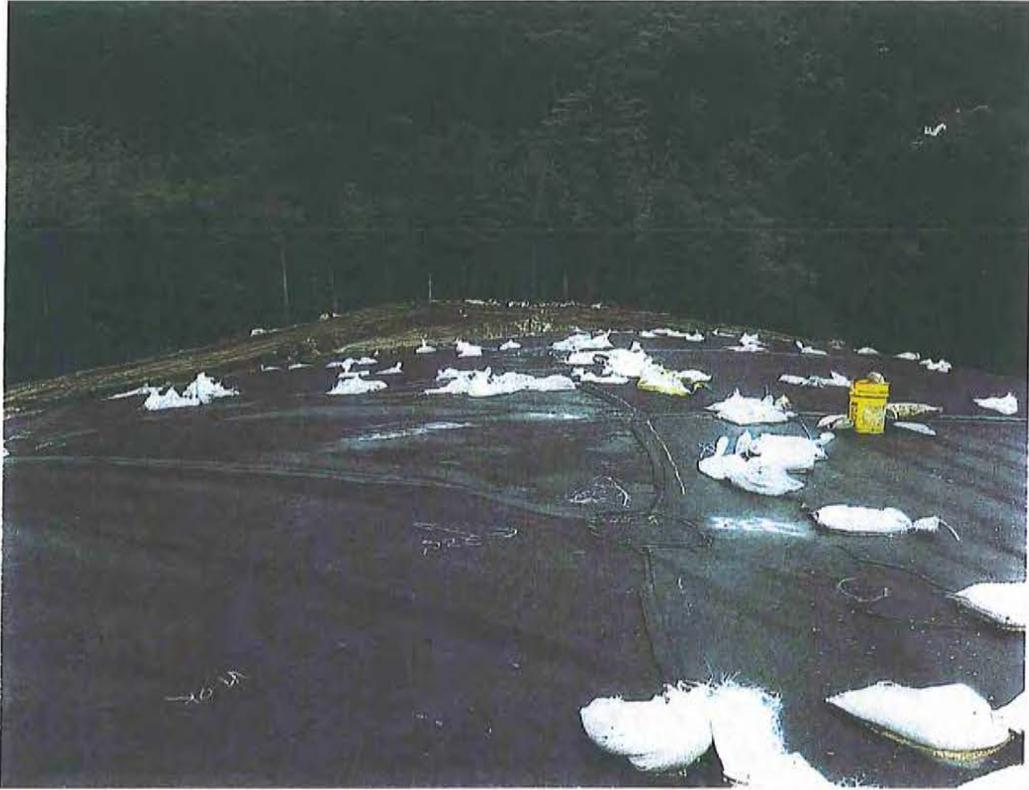
Photo 36: Pulling of geomembrane observed at vent located at the top of the northwestern slope. Liner at base of vent needs repair and boot connection.

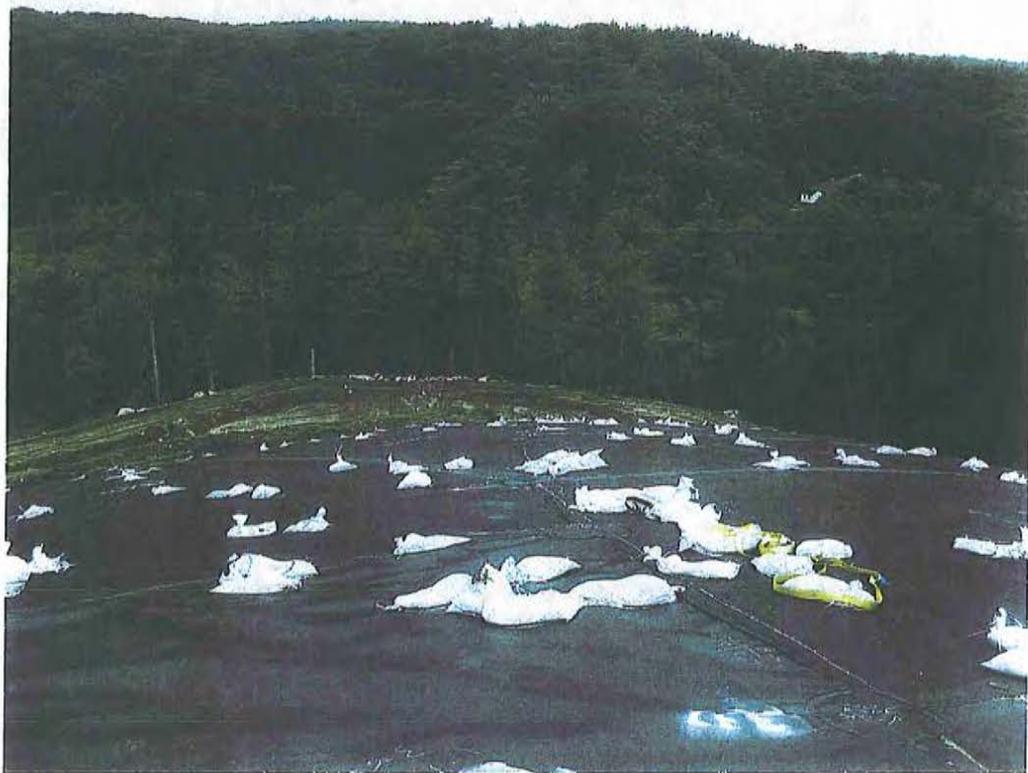
Photo 37: Western slope. No vent on this slope as designed.

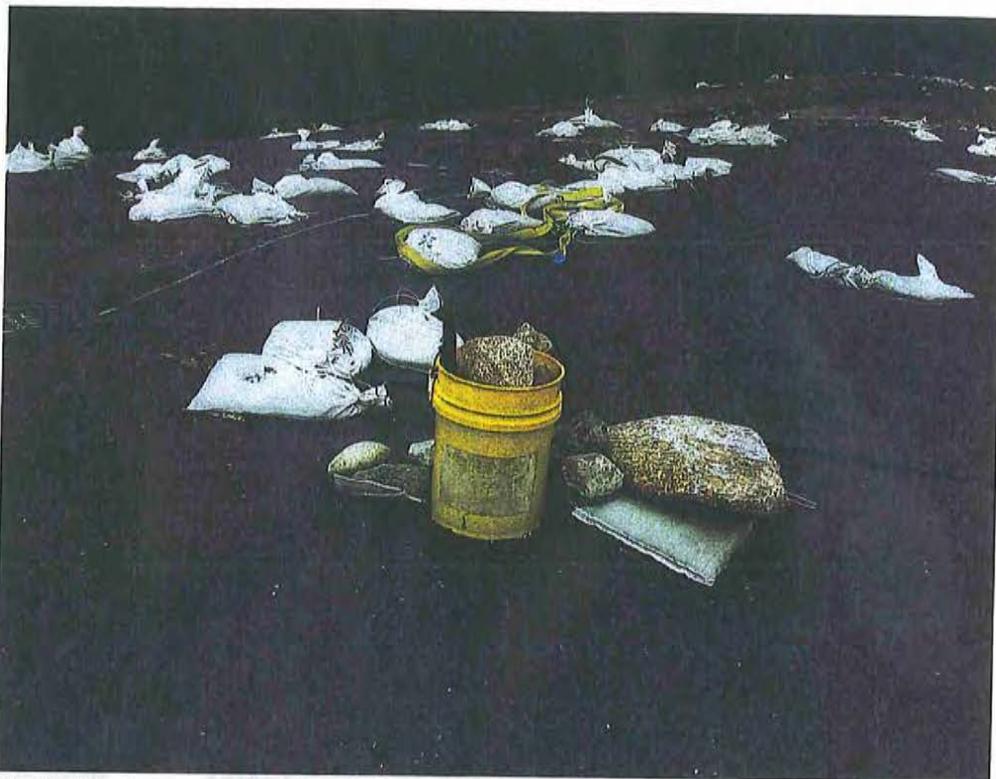
Photo 38: Western slope. No stormwater benches observed.

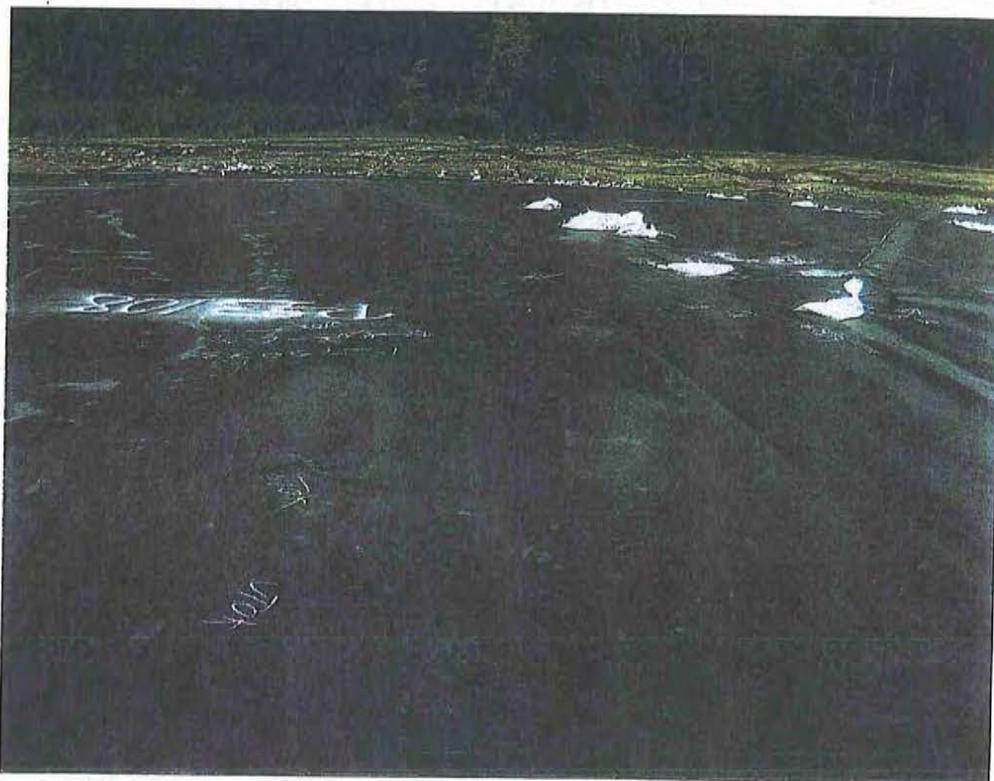
Photo 39: Large rocks observed on liner.

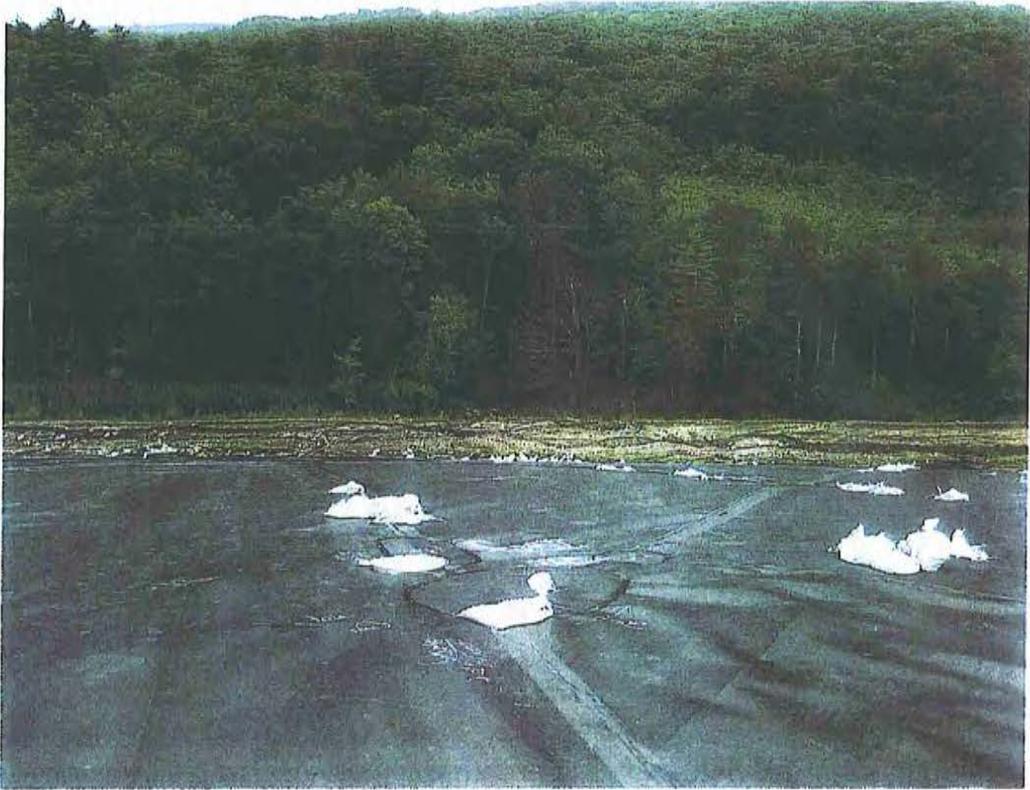
Photo 40: Southwestern slope; many creases in geomembrane observed. Significant creases were reinforced with extrusion welds.

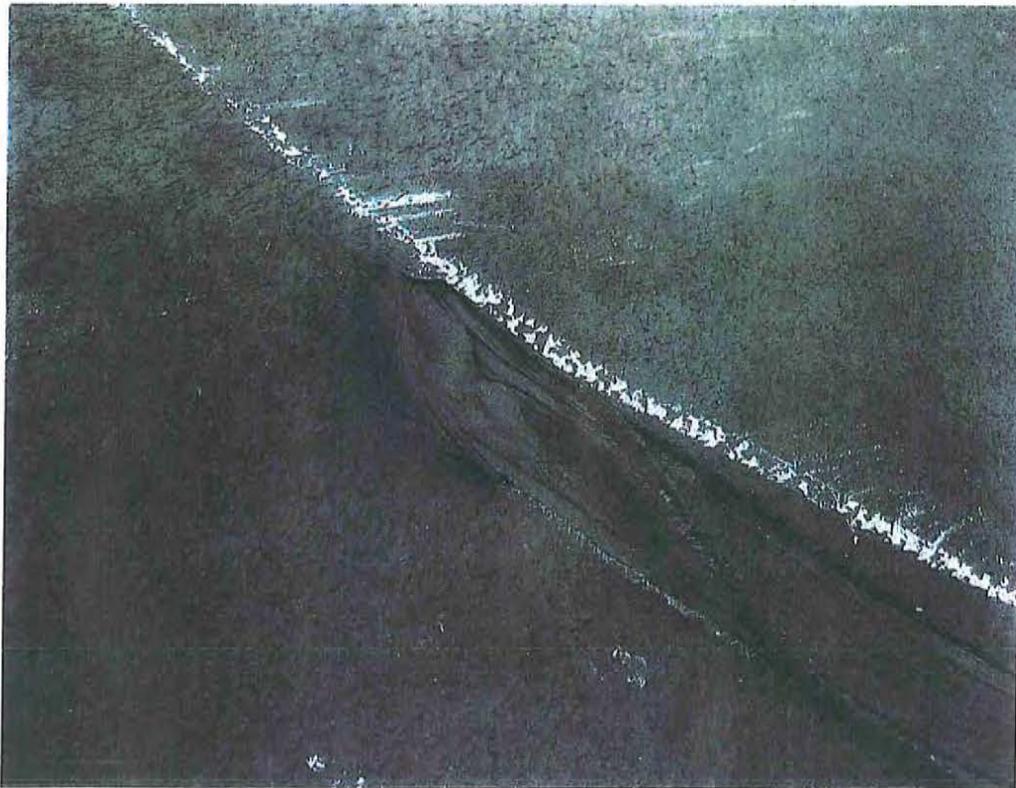
Photo 43: Two different types of textured geomembrane seamed together.

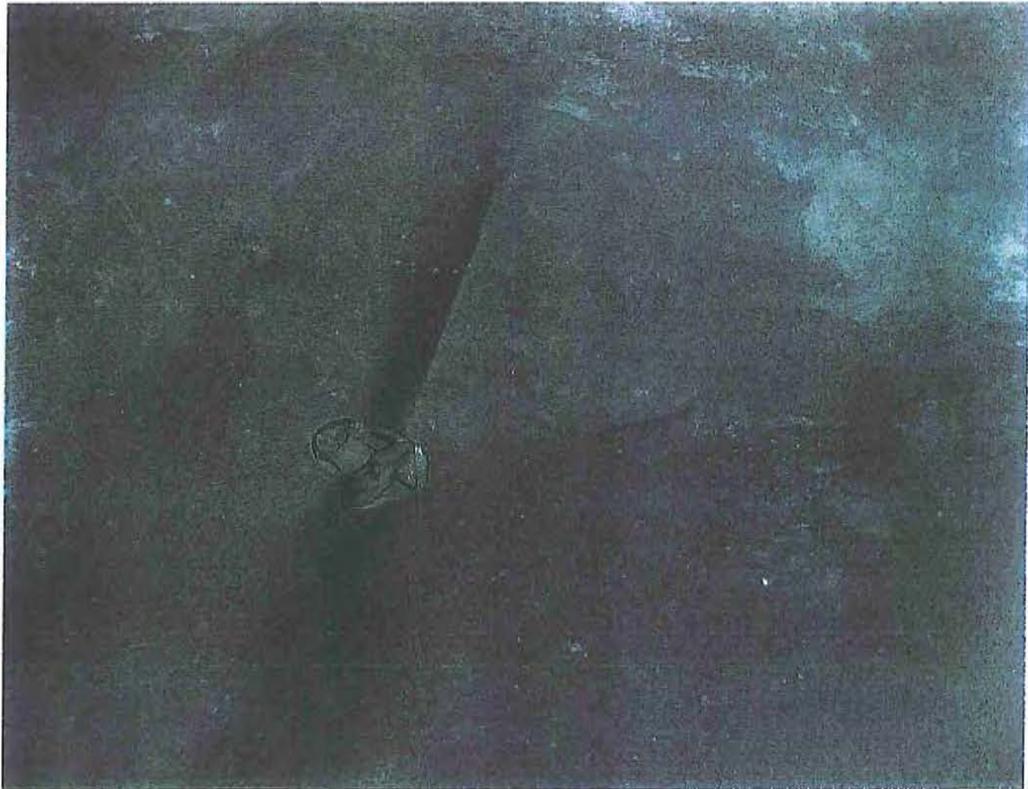
Photo 44: Extrusion weld on crease observed to have separated from liner at one end.

Photos 45 & 46: Creases in geomembrane on southern slope.

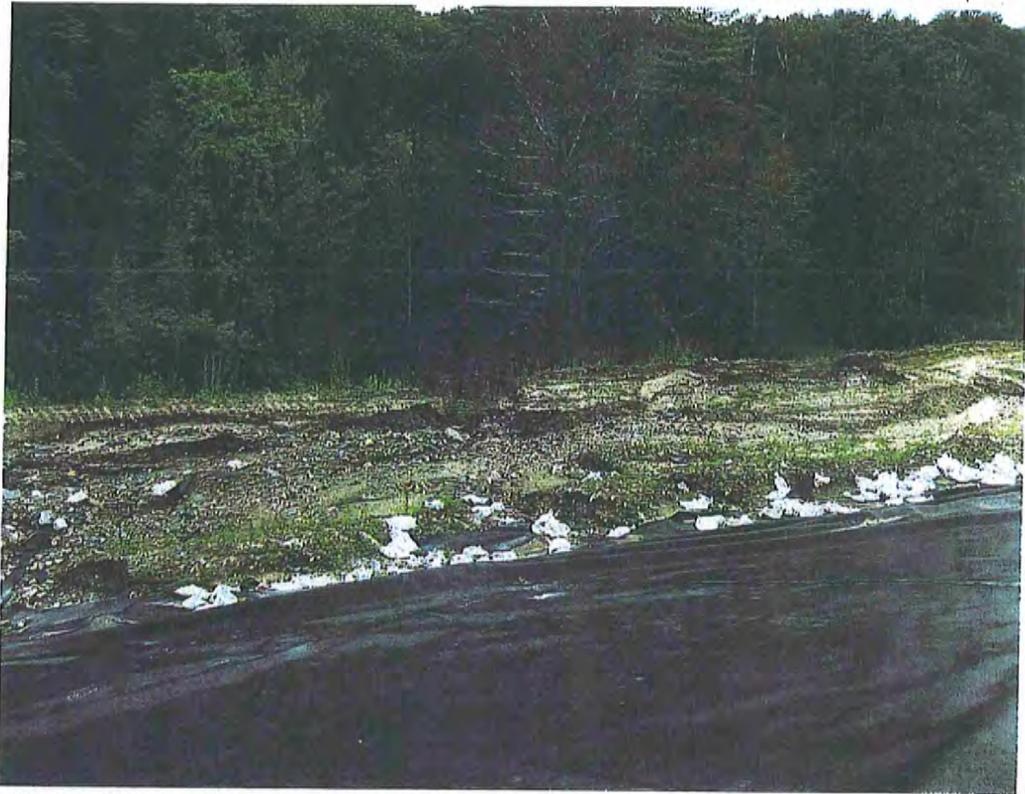
Photo 47: Toe of southern slope. Significant erosion observed.

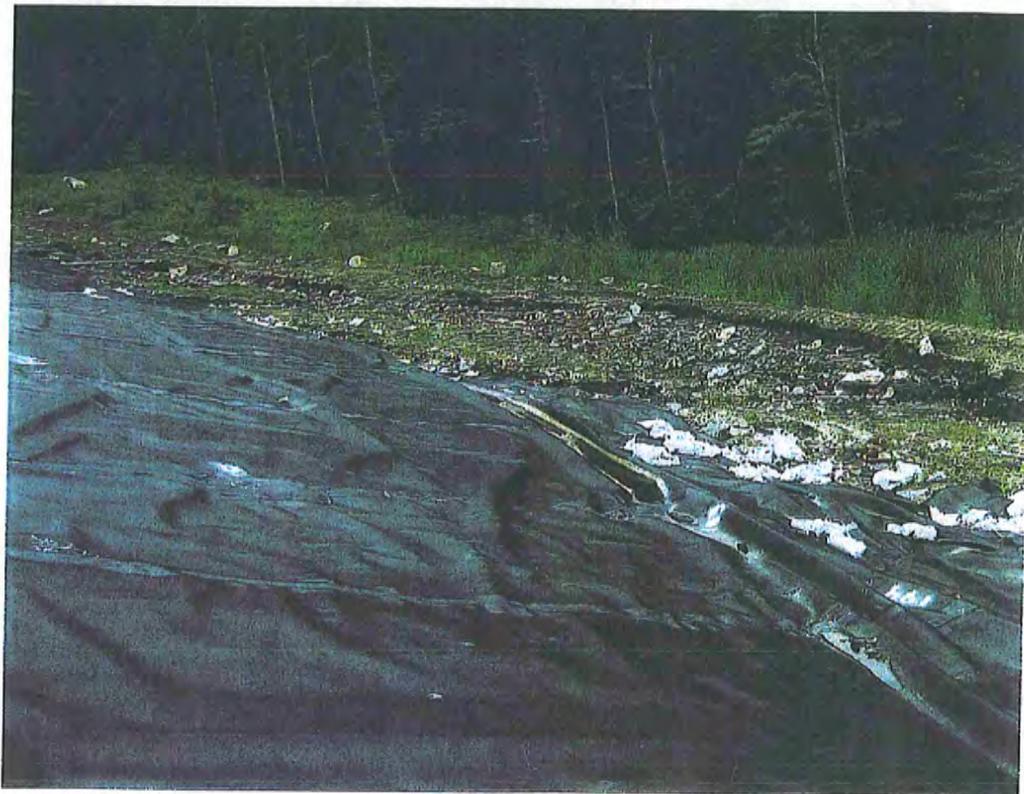
Photo 48: Toe of southeastern slope. Significant erosion observed. No drainage swales observed.

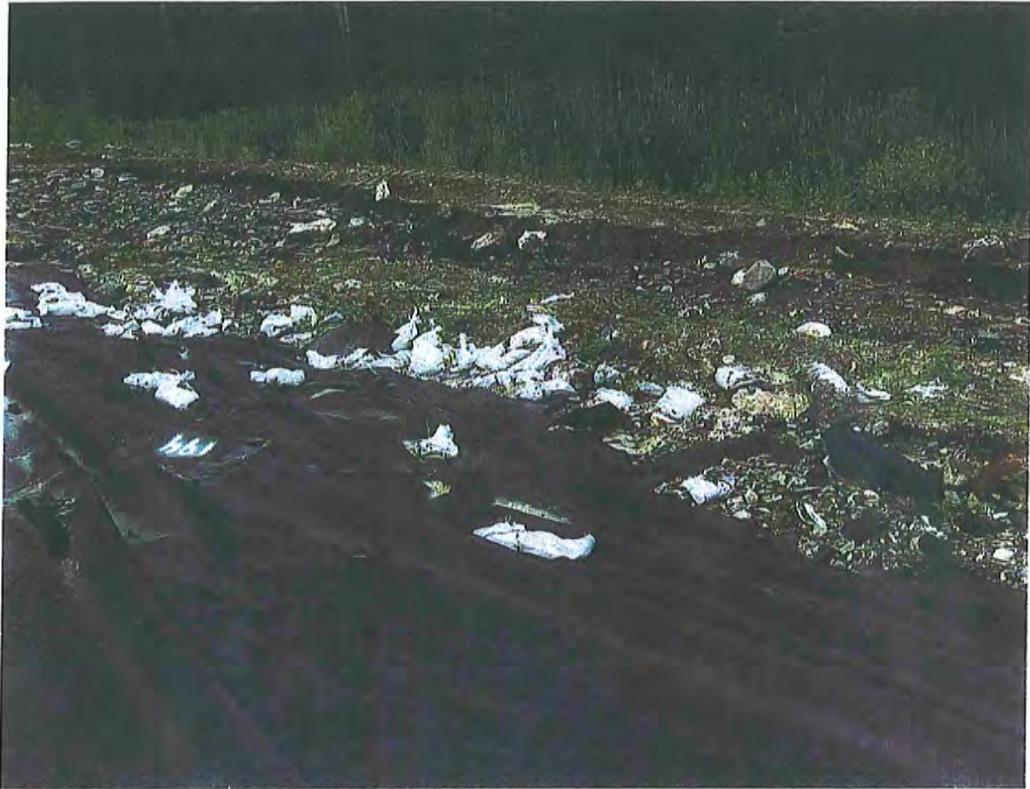
Photo 49: Toe of southern slope; No anchor trench observed. Edge of landfill appeared to have been built up with imported soils.

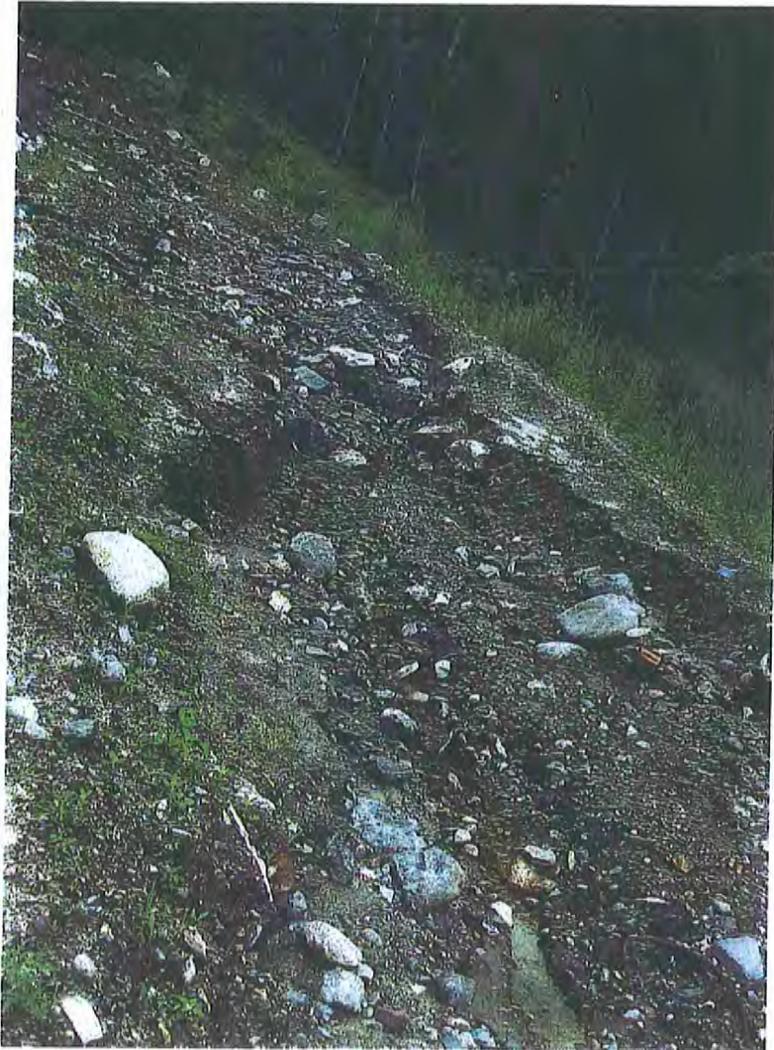
Photo 50: Erosion at toe of southern slope (facing east).
Brick and metal observed in soils.

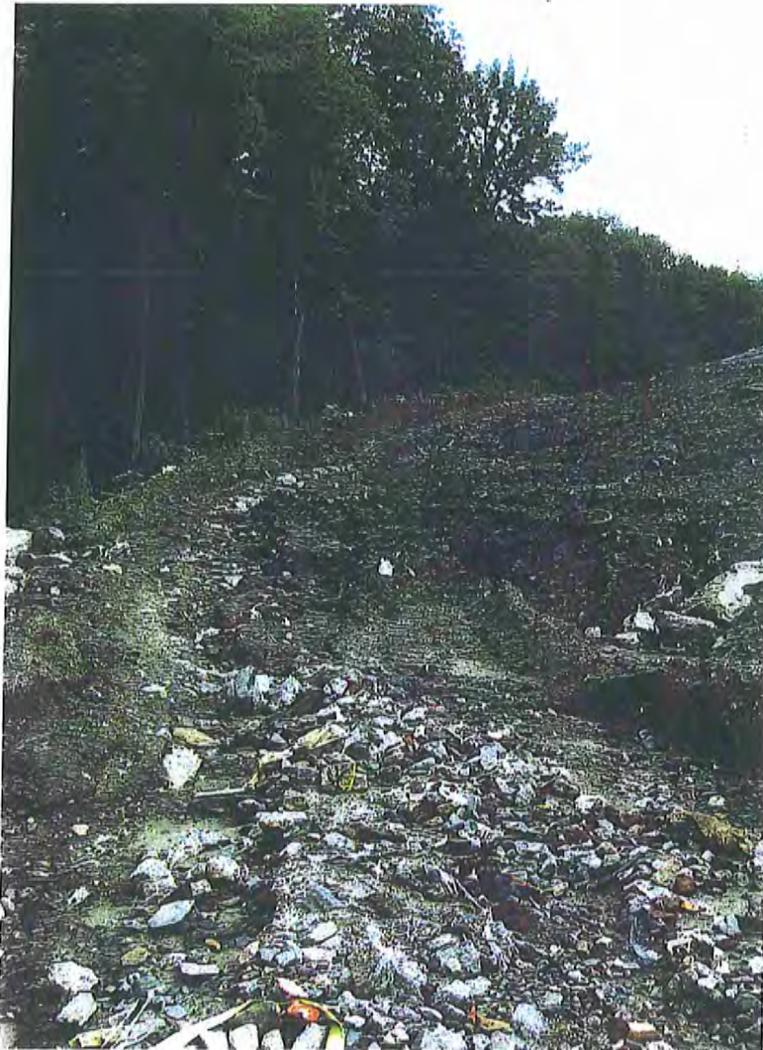
Photo 62: Sedimentation of downgradient land and wetlands located west of stormwater basin.

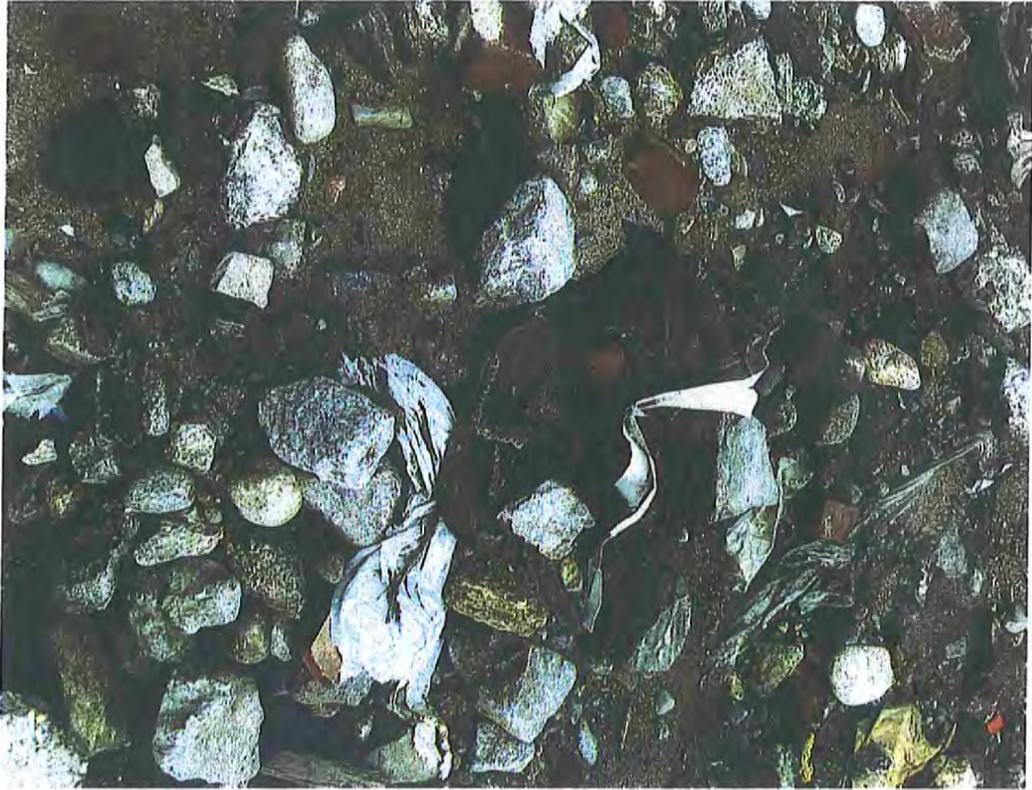
Photo 63: Toe of northwestern slope, facing northeast.
Exposed waste observed in eroded areas.

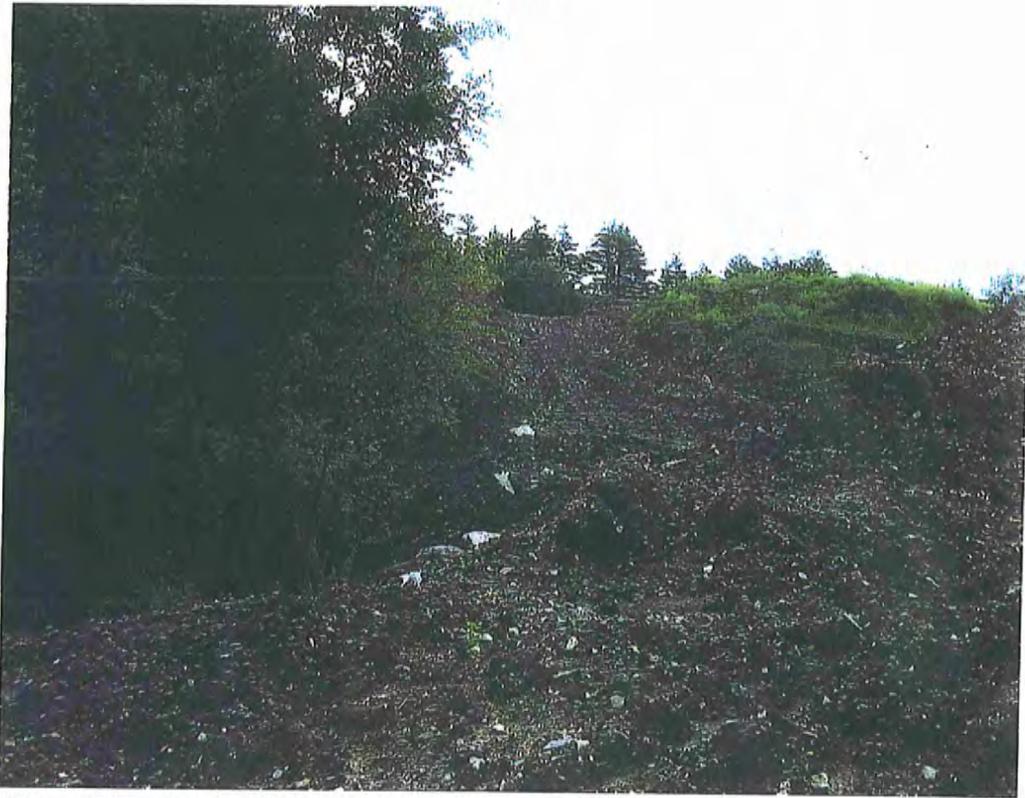
Photo 70: Pile of soils at top of plateau area. No access road over the geomembrane was observed.
